COLUMBIA COLLEGE CHICAGO
CAMPUS PRESERVATION PLAN

Volume III

72 EAST 11TH STREET

June 2005

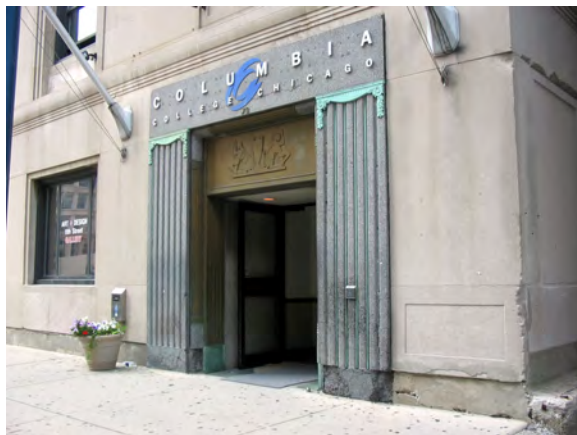
East entrance

The limestone elements are in fair condition and require routine maintenance including repointing and regular inspection. Deterioration consists primarily of spalls caused by corroded anchors and shelf angles.

- Continue regular façade inspections and maintenance.
- Repair limestone particularly at areas where corroding anchors have caused stone "pop outs". Deteriorated anchors and shelf angles should be cleaned or replaced as needed. Apply

corrosion protection, such as painting of anchors, angles and flashing. Voids resulting from spalls should be patched or filled with a permanent Dutchman repair.

- Repair the cast stone and bronze surrounds at both door openings. The missing bronze elements should be replicated and the bronze panel above the door should be restored.

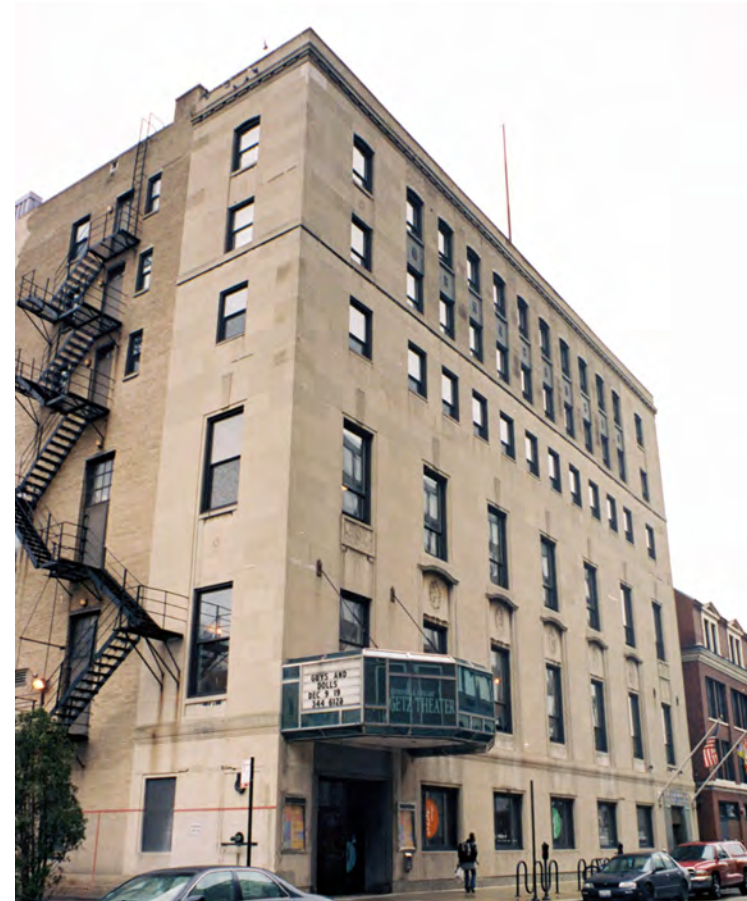
South façade and west return

The building has entrances, framed with a cast stone surround, at each end of the façade. The east entrance is the main entrance to the building and its cast stone surround is accented with metal ornament. The cast stone is in fair to poor condition, while the bronze is in fair condition with some missing pieces. Deterioration of the cast stone is occurring primarily at the base of the wall and is possibly caused by deicing salts. The original revolving door has been replaced with a pair of aluminum doors. The west entrance leads to the Getz Theater lobby. The original metal doors and transom at this entrance have been replaced in aluminum. When these doors were replaced, the original transom grillwork was preserved and rehung on the interior of the transom. The original canopies that sheltered both entrances have been removed and a newer canopy has been installed over the west entrance.

- Restore base material along the primary façade. This missing material likely was cast stone. Install new base that replicates the original but is more durable.

- Install window boxes that were originally located below each of the second floor windows.
- Provide a canopy over each entrance to match originals. The canopy above the west entrance is not compatible with the historic character of the building. Historic photos and original architectural drawings exist and would allow for an accurate reproduction of the missing canopies.

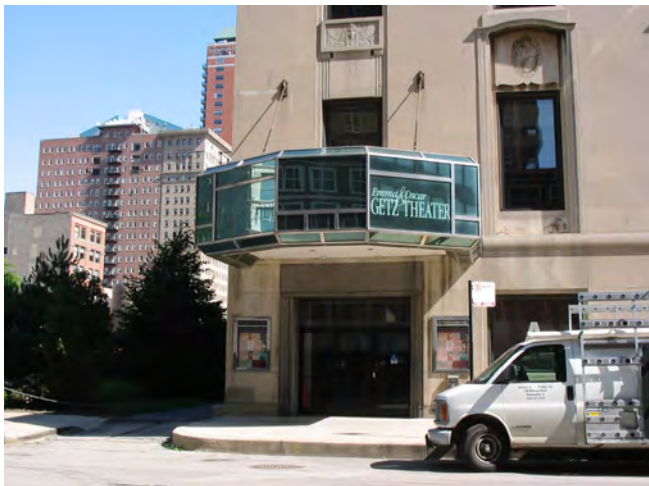
West entrance

Alterations to the primary façade and returns include the replacement of original wood windows in aluminum, the removal of the original base trim, removal of entrance canopies and replacement of one. Despite these changes, the facade retains a high degree of integrity.

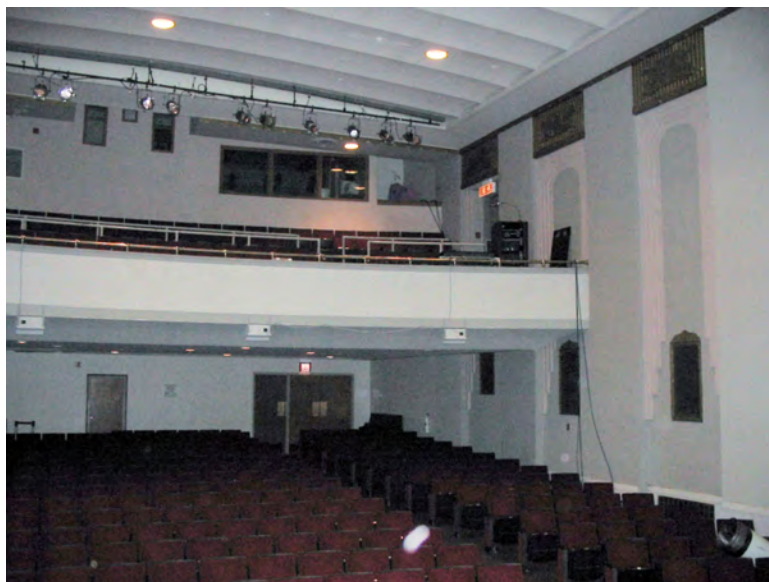
Getz Theater

Despite modifications, most original surfaces and elements remain and the Theater retains a high degree of integrity. The walls are of flat plaster with insets along the east and west sides. (The stepped detail within each inset is a later addition.) The east and west walls have wood wainscoting and trim. The main ceiling is of scalloped plaster with flat plaster at the perimeter and a flat plaster soffit beneath the balcony. The floor is concrete that has been recarpeted and the original fixed seating has been replaced. The design of the ornamented railing for the rear stair is the same as the building's Main Stairway.

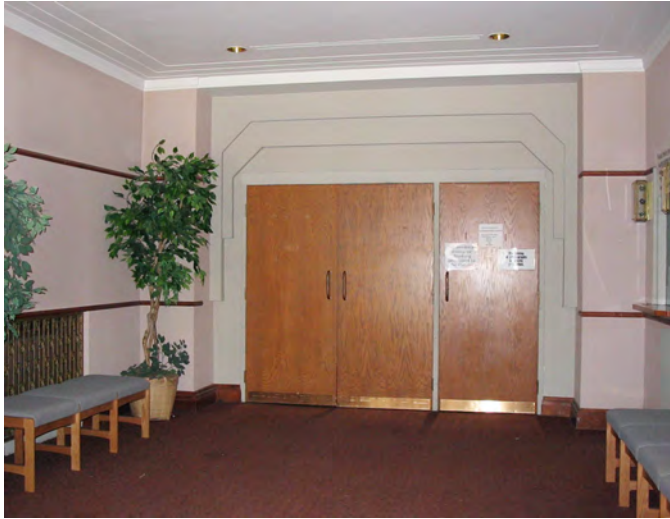
West Lobby

The ceiling is of flat plaster with a stepped detail around the perimeter and a plaster cornice molding. The walls are plaster, with areas of gypsum board. The floor of the Lobby is carpeted, however original drawings show a terrazzo floor, which may remain. The vestibule has terrazzo flooring with a recessed mat. The original box office window is located at the east wall and has an etched glass window set in wood. Metal grilles are located along the west wall. The vestibule has a large metal grille at the east wall, opposite an original wood closet door.

- Restore the West Lobby and Foyer. Removal of the gypsum board walls and restoration of the original wall surfaces would greatly improve the appearance and integrity of these spaces.

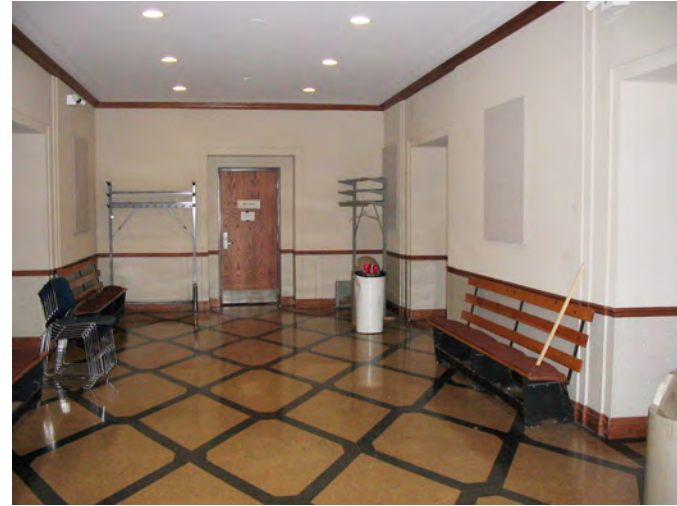
Foyer

The Foyer originally served as a circulation space between the Theater, the Club Room (Art & Design Gallery, 103) and the Assembly Room (Classic Studio, 101). The original wood paneling of the Foyer has been removed or covered with gypsum board. The ceiling is of flat plaster, detailed with concave banding at the perimeter. The floor is of patterned terrazzo. Doors to the Theater, Club Room and Assembly Room have all been replaced with newer wood panel doors.

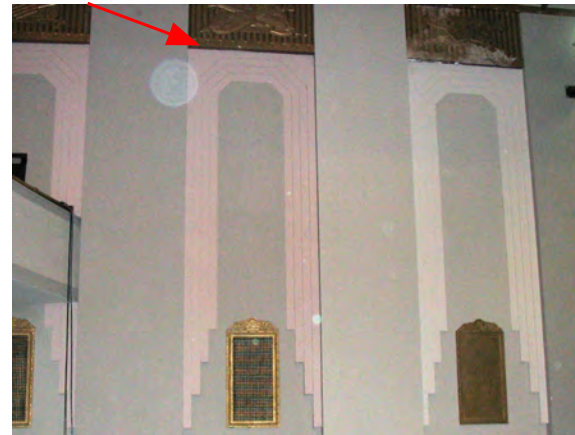
Non-original wall surfaces should be removed

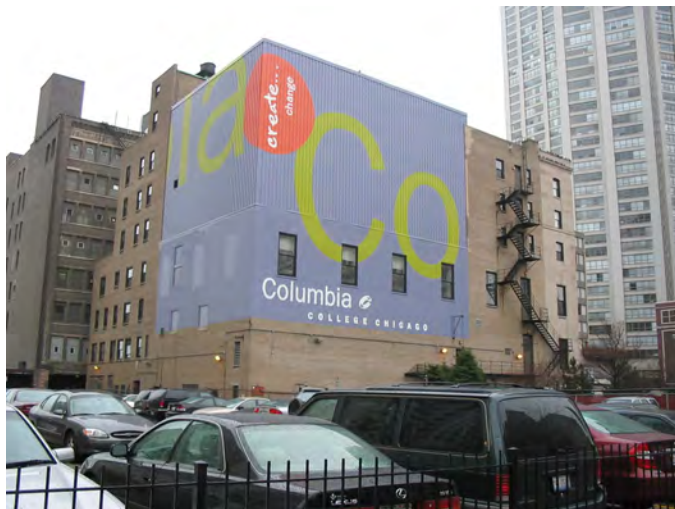
North and east facades

None of the original wood windows exist. Most have been replaced in aluminum, while the rest of the window openings have been bricked in, boarded over or filled in with louvers. At the north façade, additional

openings have been made for louvers. All original doors have been replaced with steel doors. The original door frame and transom remains for the rear stair exit and most of the fire escape exits. The fire escape, which is original to the building, is located at the south end of the west façade.

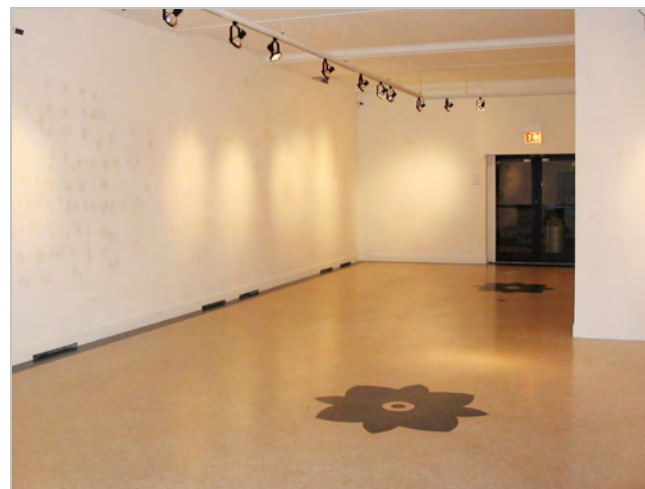
Club Room (Art & Design Gallery, 103)

Two door openings are located on each the north and south walls. All doors have been replaced with newer wood panel doors. The openings along the south wall originally had double doors and have been in-filled to accommodate the smaller doors.

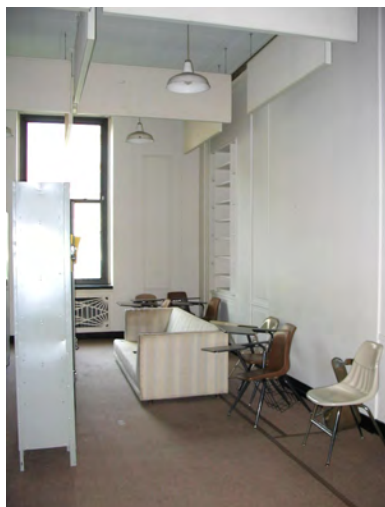
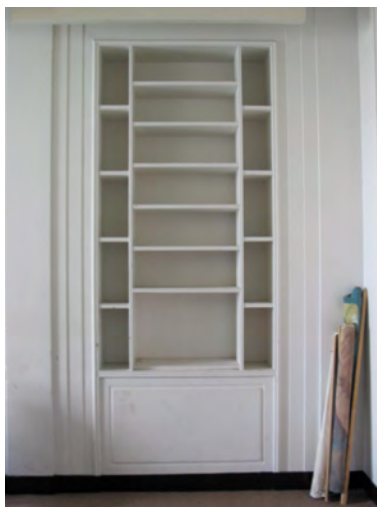
Library (Room 307), general view (left) and detail of built-in shelving (right)

Three built-in shelving units remain along the south and north walls. The two narrow units that flanked the window on the west wall have been removed or covered over. Below the window is an ornamented radiator

grille that is similar in design to the grilles found in the Third Floor Lobby. The fireplace that was located at the center of the north wall has been removed and the opening has been walled over.

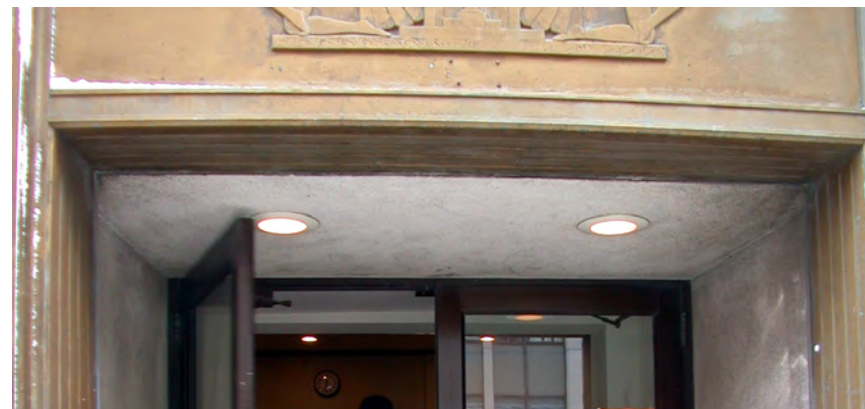
South elevation – downlights above main entry.

- If planned restoration work involves the replacement of the original entry canopies, then the installation of lighting fixtures to replicate the originals should be considered.

- If replicating the originals proves too daunting, downlighting may be integrated within the canopies so as not to call attention to itself. New fixtures should be sensitive to the architecture.
- At the very least, consideration should be given to replacing the existing downlights in the west canopy and the east entrance. The current fixtures have lamps partially exposed, creating unnecessary glare, which may detract from the appearance of the building.

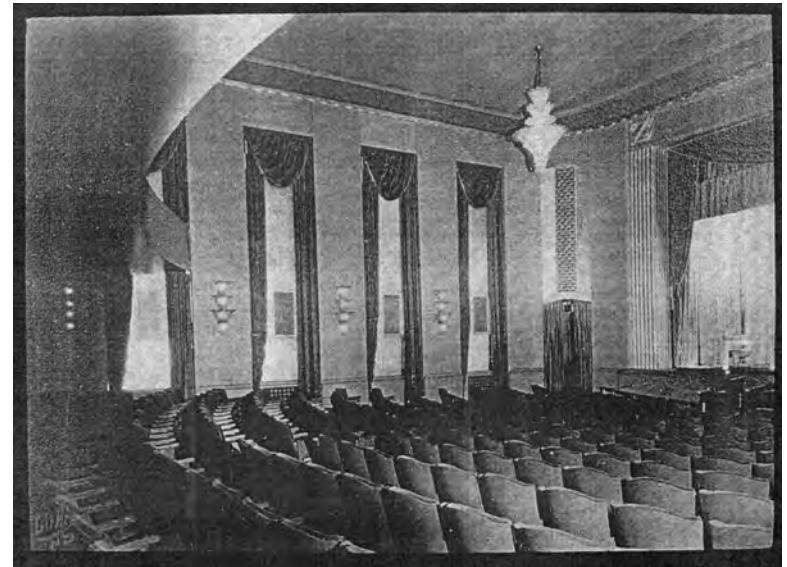
Getz Theater – historical photograph.

- Since the original lighting with the Getz Theater may not be considered adequate by today's standards, any changes made should be sympathetic to the architecture. Decorative fixtures selected and/or designed to reflect the originals should be installed in the original locations, while additional functional lighting should be integrated carefully into the architecture and decorative fixtures so as to be unnoticeable.

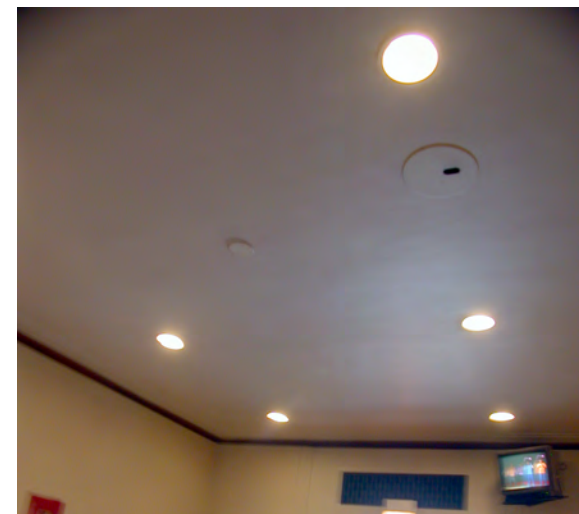
Main lobby ceiling – original fixture location visible.

- As with the spaces discussed previously, care should be taken to replace the original fixtures with new ones sympathetic to the original style and architecture. As necessary, additional functional lighting should be added,

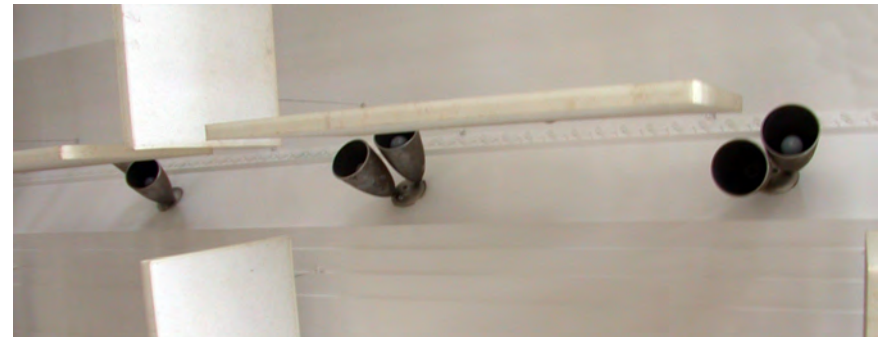
Main dining room – unused spotlights.

- The current light fixtures should be removed and replaced with fixtures sympathetic to the original architecture in the original locations. Decorative fixtures may be supplemented as needed with functional lighting, although any non-historic fixtures should remain as inconspicuous as possible.
