COLUMBIA COLLEGE CHICAGO
CAMPUS PRESERVATION PLAN

Volume IV

33 EAST CONGRESS PARKWAY

Submitted by
McGuire Igleski & Associates, Inc.

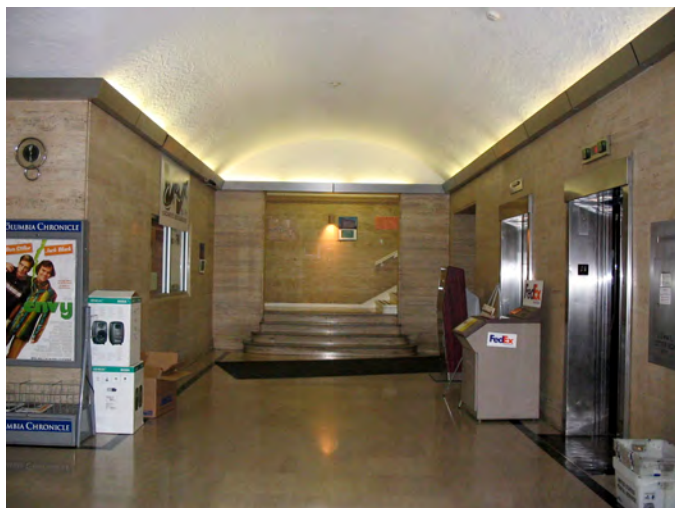
Main Stairway at west end of lobby and elevator bank

The Main Lobby and Stairway at the Lobby retain their historic configuration and materials. Due to some alterations such as at the plaster ceiling, the addition of cove lighting, changes to the elevator doors, and the infill of an interior door with travertine, these spaces have a medium degree of integrity.

Historic elements have been rated for preservation. These elements appear to be in good condition. If any of the original material is damaged, sensitive repairs should be made; and if beyond repair, replication in identical materials is recommended.

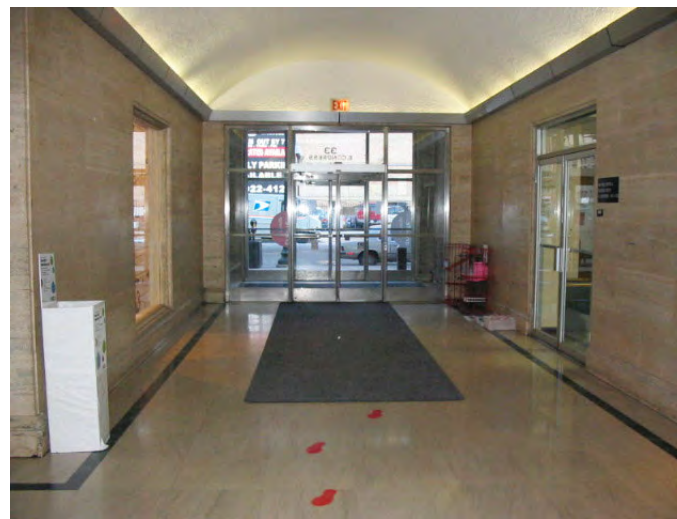
View toward east, Wabash Avenue, entrance

- Air lock heating at both entrances is important. Presently there is no heating source in these vestibules. The addition of heat to these spaces should be done in a sensitive way.
- There is a large free-standing convector at the east end of the lobby. When making lobby improvements, consider the replacement of this heater with a concealed type.

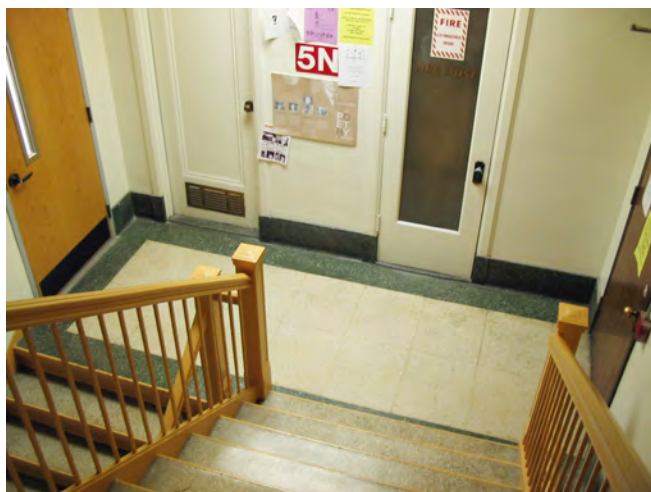
Typical floor landing in Main Stairway

The stair and landings are of metal construction with steel risers, stringers, and moldings. The landings and treads are surfaced with terrazzo. The stair railing is composed of square, cast iron balusters capped with a wood handrail. The balustrade from the first to third

Historic elements have been rated for preservation and appear to be in good to fair condition. If any of the original material is damaged, sensitive repairs should be made. If beyond repair, replication in identical materials is recommended.

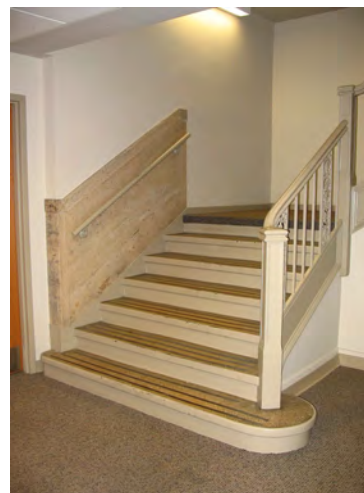
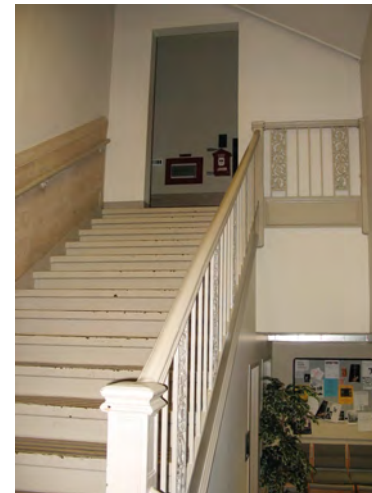
Main Stairway, view from basement (left) and up to first floor (right)

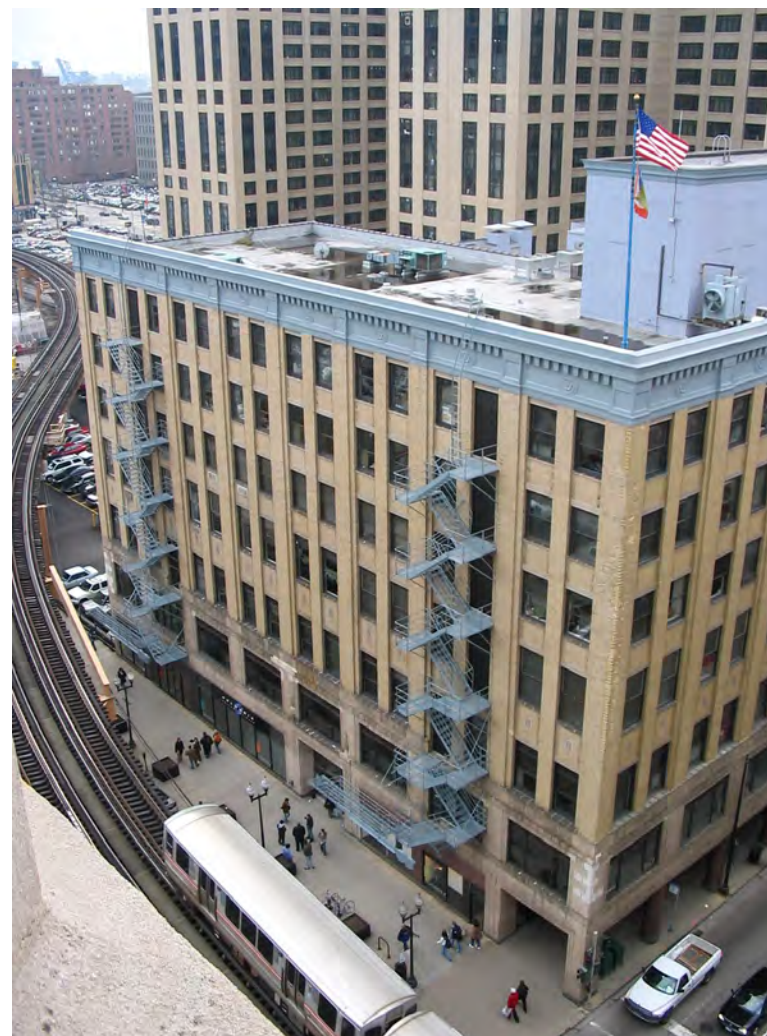
Large storefront windows line the first floor while Chicago Style windows line the second floor; all original units have been replaced. The exterior doors at the main entrances, located on Wabash Avenue and Congress

East and North facades viewed from above

- Continue regular façade inspections and maintenance.
- Maintain sheet metal cornice. Keep painted to avoid corrosion and select a color to match the terra cotta to return façade to original appearance.

- Repair and clean terra cotta. The terra cotta wall surfaces are in fair condition, with areas of soiling and cracking and some inappropriate repairs. Terra cotta repair includes the repair and replacement of deteriorated terra cotta and anchors as necessary, tuckpointing with an appropriate mortar and new sealants at wash joints and windows. Replacement units for terra cotta that is beyond repair should match the profile, texture and color of the original units.

- Repair and maintain original steel windows, casings and sills. Some of the windows are difficult to operate and are in poor condition. The casings and sills are generally in good condition.

- When replacement of the non-original windows and doors is considered, the new units should reflect the appearance of the original. This work should be done based on available historic documentation and should incorporate restoration of both materials and design, including sash configuration and profiles.

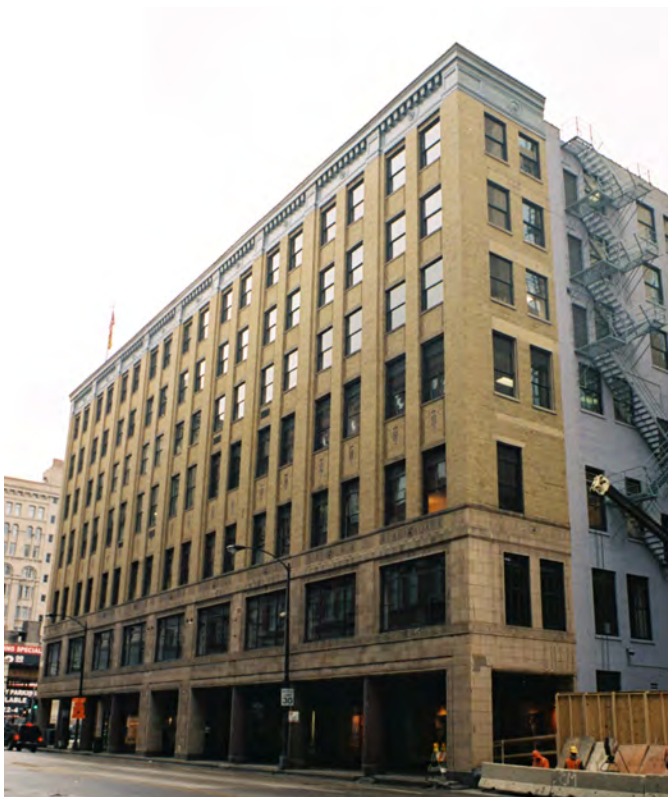
North façade with impact overlay zone at first floor

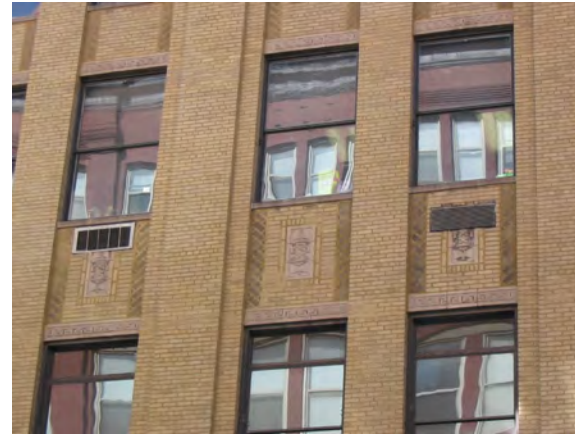
- On the east and north facades through-the-wall air conditioners have been cut into building. Large (approximately 36" by 14") louvers are evident below windows on the fourth and fifth floors. The air conditioners serving classrooms and offices could be eliminated with the cooling loads picked up by interior mounted HVAC equipment. Once the air conditioning louvers are removed, the east and north elevations will be clear of mechanical infringement. There are also mechanical vents in window openings on the northwest façade return. These could be moved to less obvious locations.
- Interior soffits at storefronts and windows, often used for HVAC and lighting, are set back from the glass. Because soffits can adversely impact the exterior facades, it is important to continue to keep soffits minimal and away from the glass.

Detail of primary façade showing louvers cut through terra cotta ornament and brick.

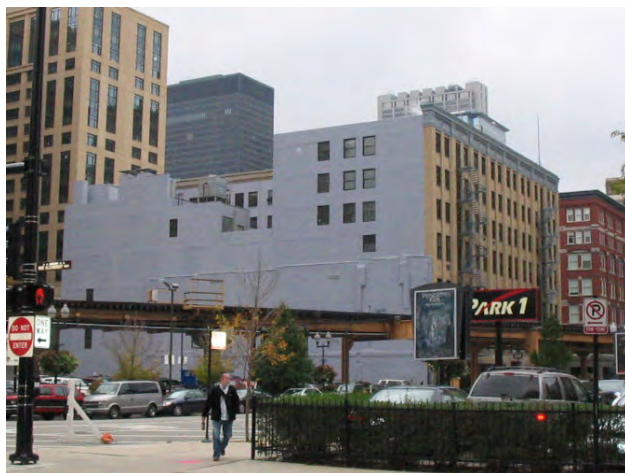
South facade

conditioning hoods and duct fittings. Also, there is refrigerant piping running up the south façade to upper roof mounted air conditioning condensers.

apparatus on the south light court elevation. These would include moving the existing and any new refrigerant piping into the building and replacing the older through the wall air conditioners on 6th and 7th floors with water-cooled or remote air-cooled models.

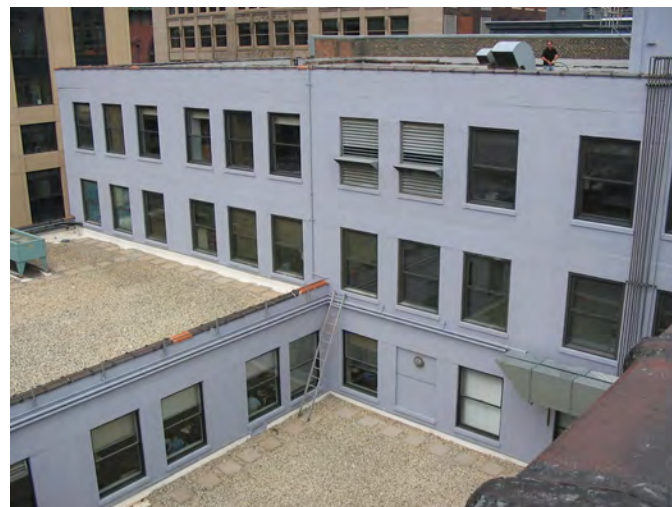
Lightcourt on floors five through seven

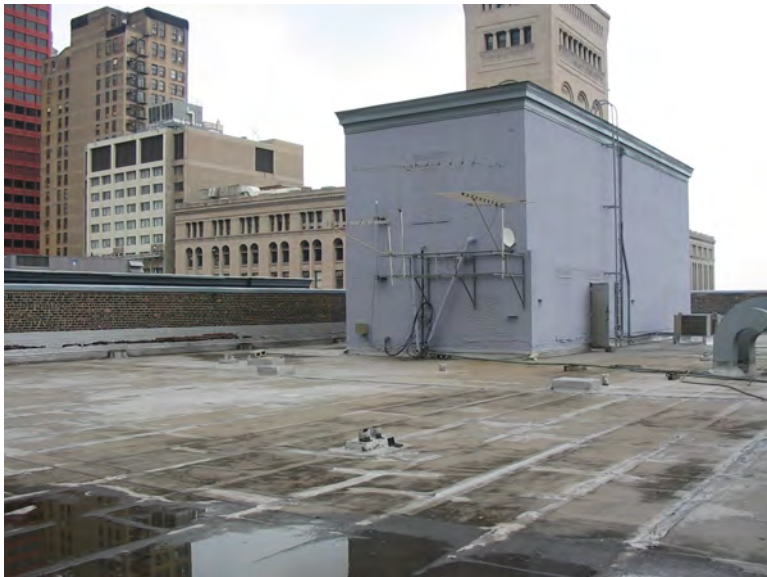
Penthouse toward northeast corner of roof

The main roof (over the seventh floor) is accessed from the original two-story, elevator penthouse, located toward the northeast corner of the roof. The penthouse has brick walls capped by a sheet metal cornice

and is recessed from all four facades. Original window openings on the penthouse have been bricked in, however the terra cotta sills and ornamented lintels remain. An original flag pole is located in the northeast corner of the main roof.

the building. Elements that have been identified as historically important, such as the brick masonry, sheet metal cornice, terra cotta window sills and lintels and flag pole, should be preserved. Elements visible from the ground should be maintained. If replacement is necessary, use compatible material and design. Elements appear to be in good to fair condition. Work in this zone should be undertaken as sensitively as possible; however, contemporary methods, materials and designs may be selectively incorporated. New work in this zone should respect the existing historic fabric.

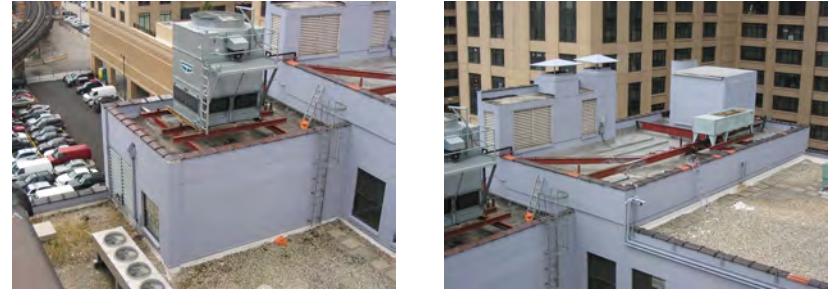
South portion of roof (left) and southwest corner (right)

Mechanical equipment on the surface of the roof includes an air conditioning cooling tower at the south end of the lightcourt, an abandoned cooling tower on the north side of the roof, three older condensing units on the west side of the fifth floor roof and two older HVAC units on the east seventh floor roof. Elevator equipment and a domestic water tank and pump are located within the northeast penthouse. Original brick chimneys and a metal smokestack are located at the southwest corner of the roof.

- The air conditioning cooling tower is highly visible at the roof line of the south elevation. If the water-cooled heat rejection system is expanded, new cooling tower(s) could be placed on the lower fifth floor roof out of the line of sight. The exhaust vents and chimney top at the west side of the south elevation could be improved aesthetically when upgraded.
- The abandoned cooling tower on the north side of the roof

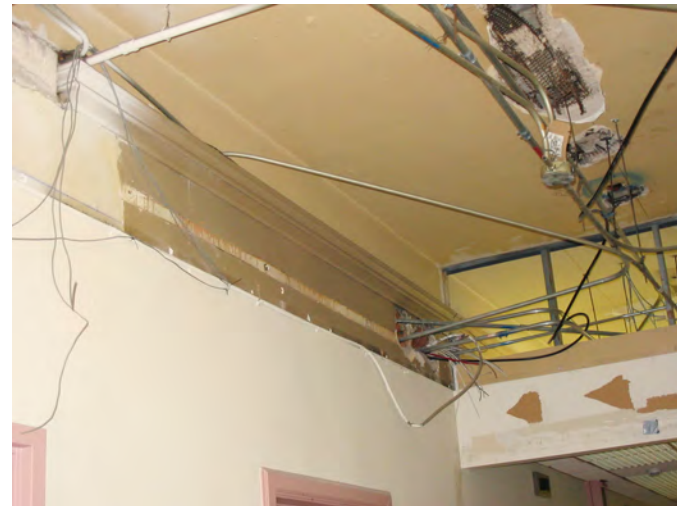
Elevator lobby showing plaster wall and ceiling and woodwork visible above dropped ceiling.

- Continued preservation of terrazzo wall trim is recommended.
- Continued preservation of the wood wall trim obscured above dropped ceilings is recommended. Although the dropped

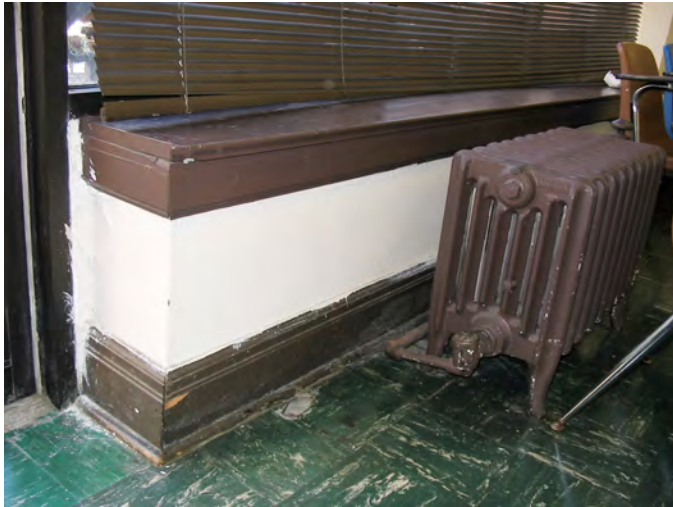
Original plaster, wood base trim and window stool, and radiator

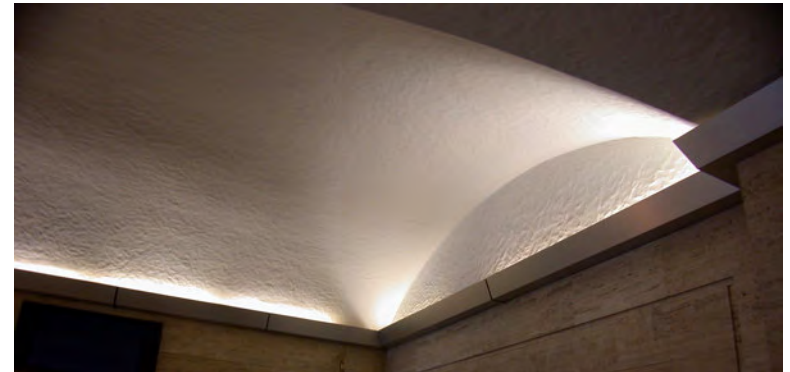
Main lobby – uplighting cove.

- None of the current lobby lighting appears to be original. These fixtures should be removed and replaced with lighting and materials that are sympathetic to the building's original design.

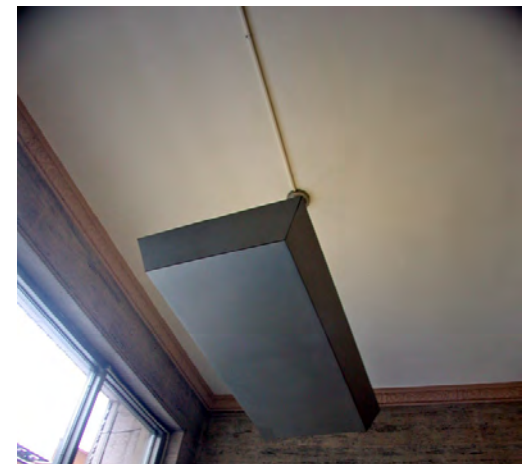
Main lobby – pendant in entry vestibule.

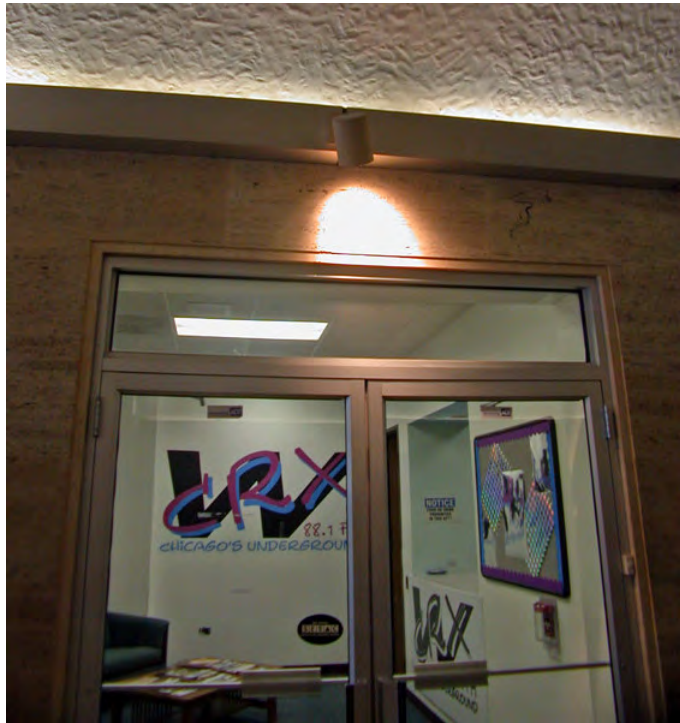
Main lobby – wall-mounted spotlight.

- New, historical fixtures may need to be supplemented with additional functional lighting. The impact and visibility of these fixtures should be minimized.

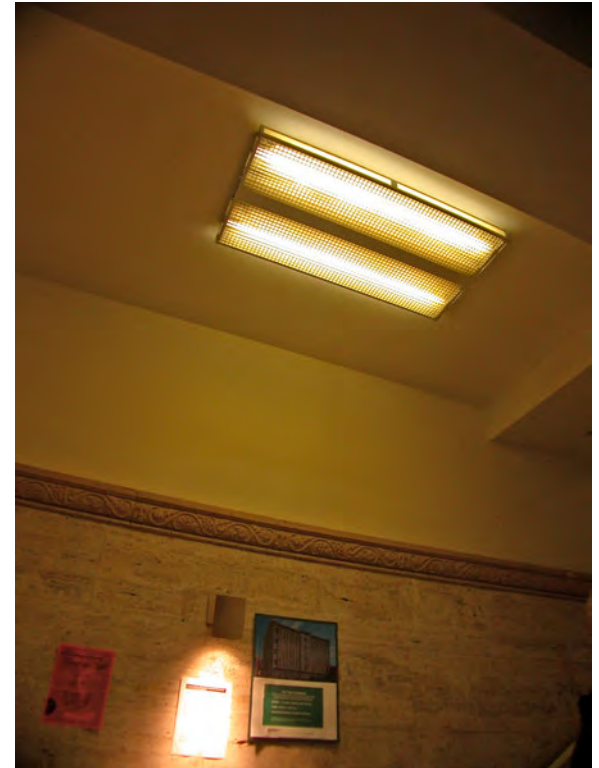
Main stairway at lobby – surface-mounted troffer and wall-mounted spotlight.

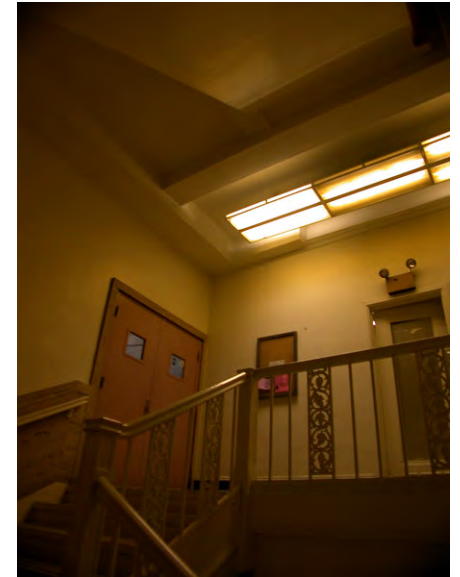
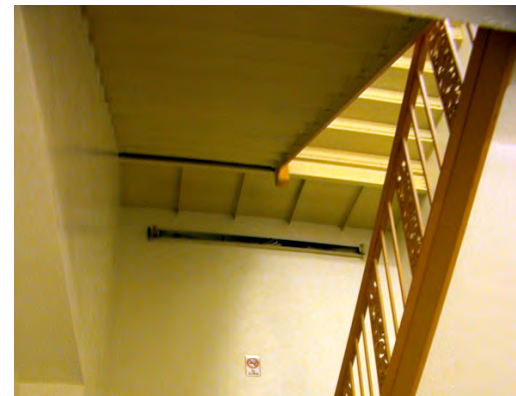
Main stairway above lobby – surface-mounted troffers and battery-powered emergency units. (right) Broken striplight at intermediate landing. (below)

- The existing fixtures should be removed and replaced with lighting that is more sensitive to the architectural character of the space.
- New, historical fixtures may need to be supplemented with additional functional lighting. The appearance of these fixtures should be minimized.

- If permissible by code, the battery-powered emergency units should be removed. New emergency lighting should be provided through emergency circuits in existing light fixtures.
