COLUMBIA COLLEGE CHICAGO  
CAMPUS PRESERVATION PLAN

Volume V

600 SOUTH MICHIGAN AVENUE

Submitted by  
McGuire Igleski & Associates, Inc.

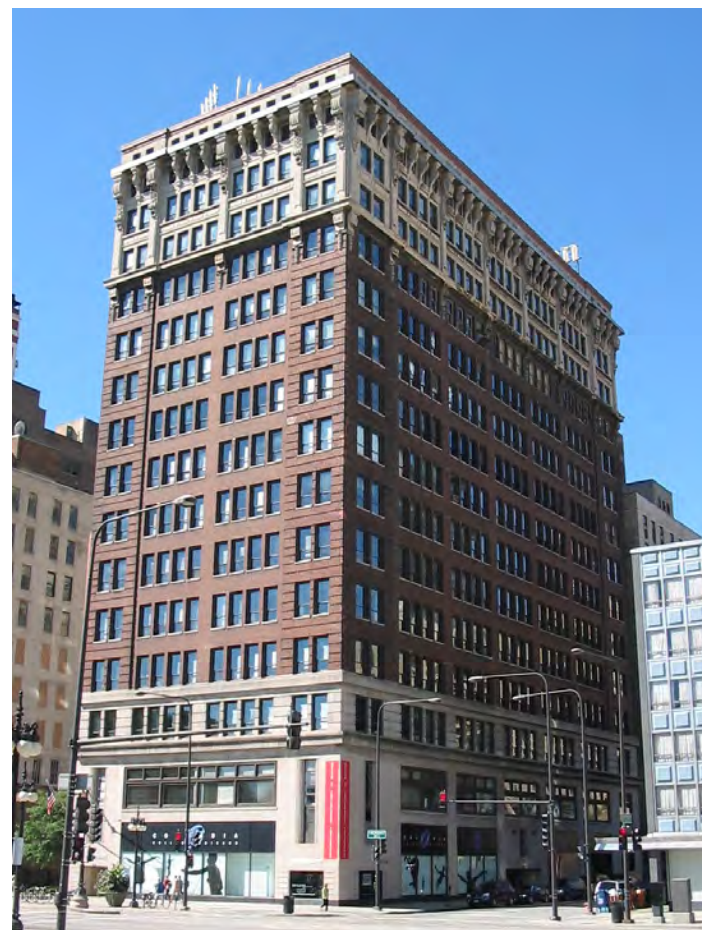
*Primary facades, facing east and north*

The cast stone wall base was observed as having some spalling and is in need of patch repair. The brick wall surface was observed as having some spalling and inappropriate patch repairs.

The limestone wall surface and ornament has some cracks and spalls. Some of the damaged limestone has been poorly and insensitively patched. These inappropriate patches adversely affect the building's

The wood window elements were observed as having damage from weathering and missing paint. The steel windows have been sealed with caulk from the interior.

- Patch damaged limestone using material to match existing. Consider staining the present, poorly matched limestone patches with appropriate color. Maintain by performing routine inspections to locate and correct causes of deterioration.

- Repair and maintain brick using appropriately matched materials and color. Restore areas previously repaired in poorly matched brick and mortar.
- Repair wood windows, casings and sills. Maintain all wood elements with paint to protect them from deterioration.

- Repair and maintain steel windows and frames.
- When replacement of the non-original windows, storefronts and doors is considered, the new units should reflect the appearance of the original. This work should be done based on available historic documentation and should incorporate restoration of both materials and design.

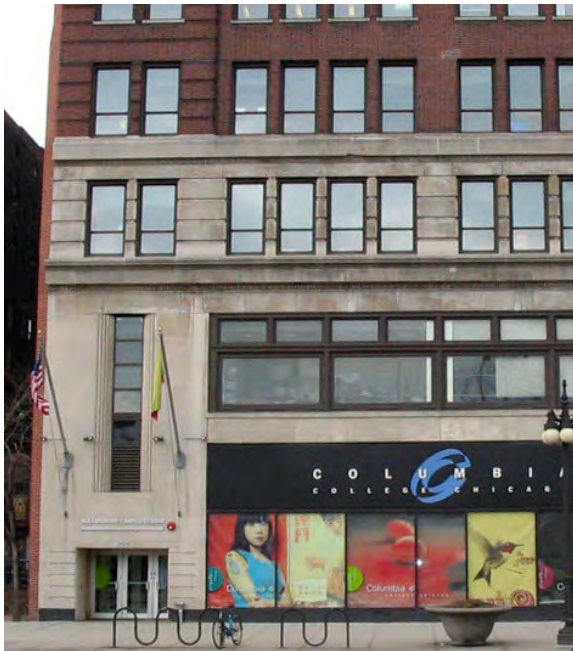
*Detail of lower floors at north end of Michigan Avenue facade*

- Continue regular façade inspections and maintenance.
- Repair cast stone base including minor patching using

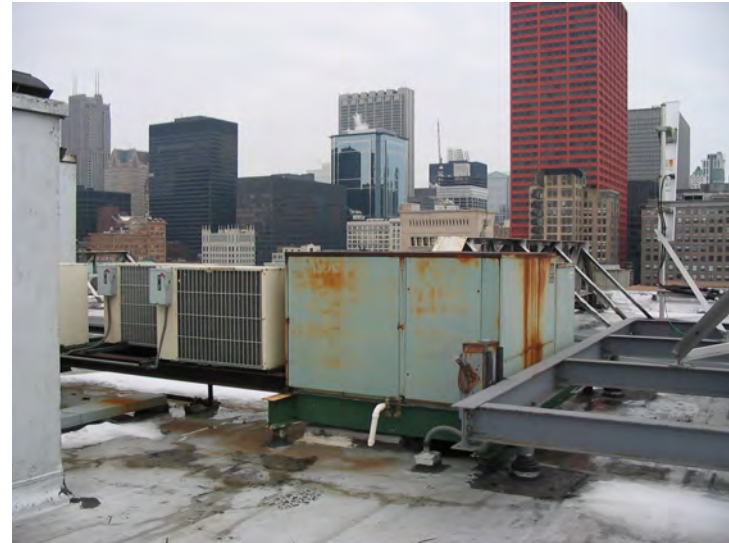
HVAC units and a cell phone relay station are located on the surface of the roof and elevator equipment and a water tank are located in the penthouses.

*Roof view looking northwest*

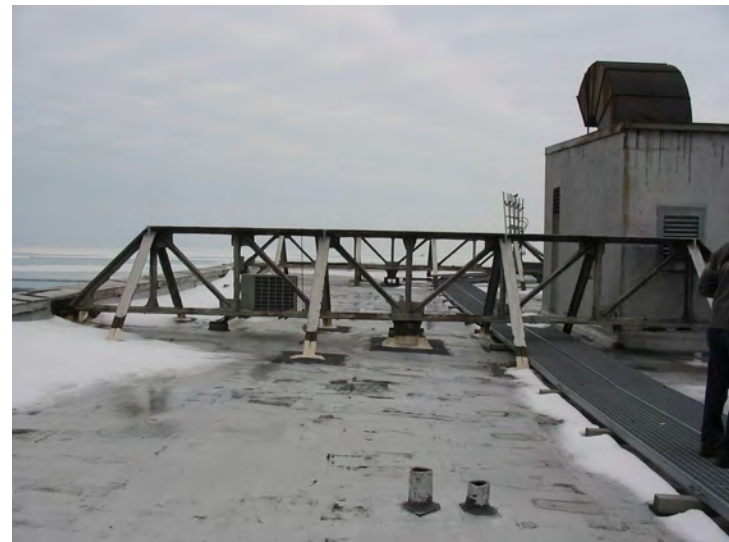
*Roof view looking east*

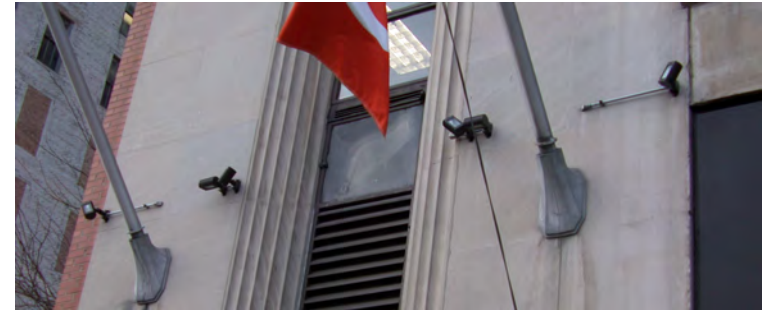
- The black floodlights and exposed electrical conduit are not integrated within the architecture. These fixtures should be removed and a new lighting scheme, integrated with the building or nearby street lighting poles, should be designed.

East elevation – floodlights and exposed conduit.

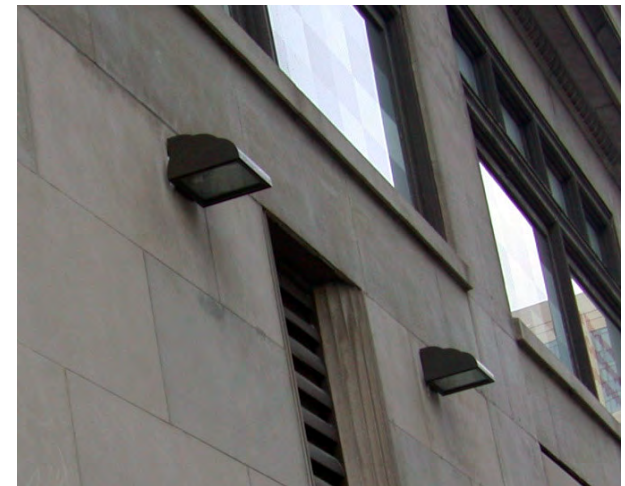
North elevation – floodlights.

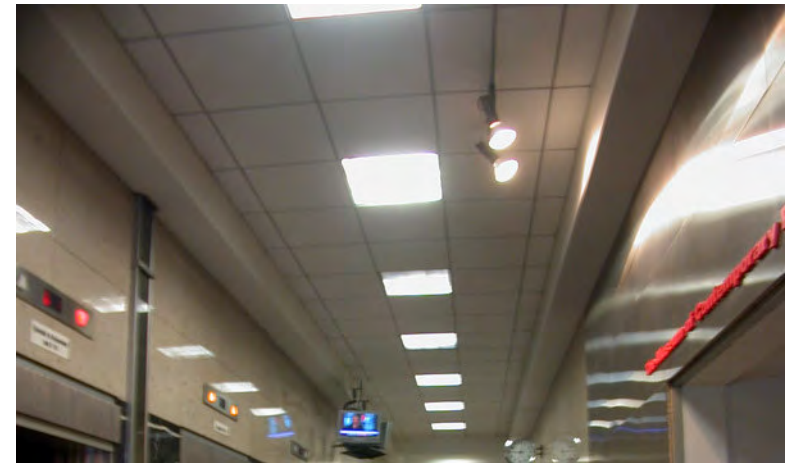
- The current fluorescent troffers should be replaced with fixtures more sensitive to the lobby's character; though they provide a sufficient quantity of light, they create noticeable, distracting reflections in the marble walls and other polished

Entrance lobby – recessed troffers and trackheads. Note the bright reflections in the space's polished surfaces.

surfaces. The original fixtures were likely pendants, though no evidence exists of their original appearances or locations. Replacement pendants should be selected and/or designed to be as sympathetic to the space as possible.

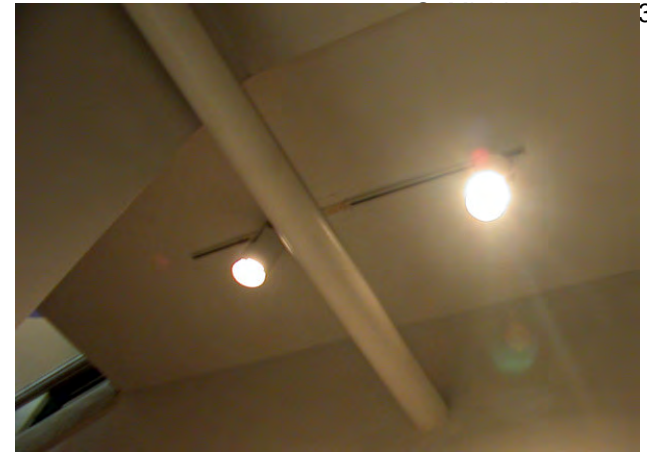
Main stairway – surface-mounted track.

- New, historic fixtures may need to be supplemented with additional functional lighting, though the impact and visibility of these fixtures should be minimized.

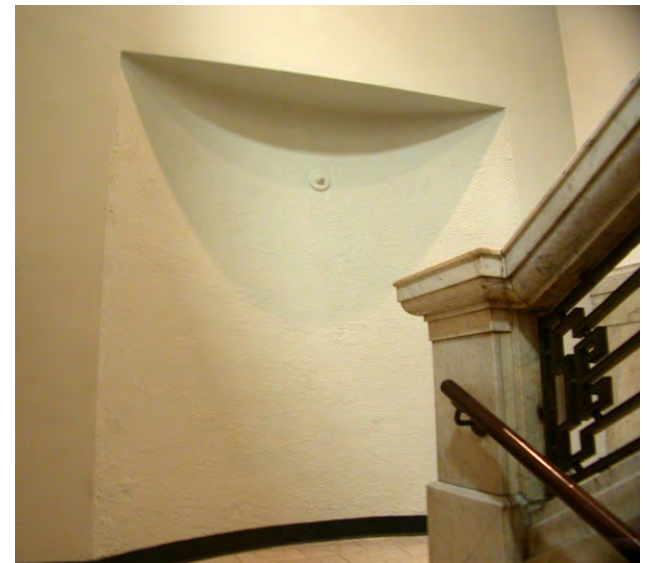
Main stairway – possible original sconce location.

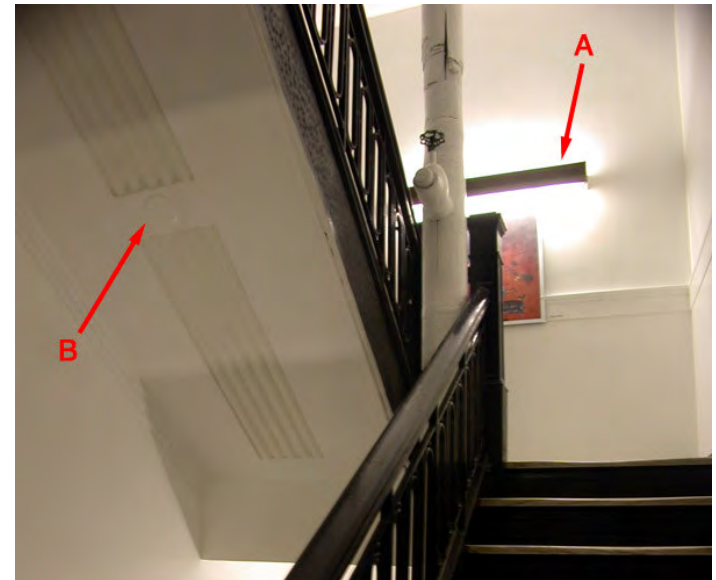
East stairway – existing fixture (A) and previous fixture location (B).

fixtures, the appearance of these fixtures should be minimized.

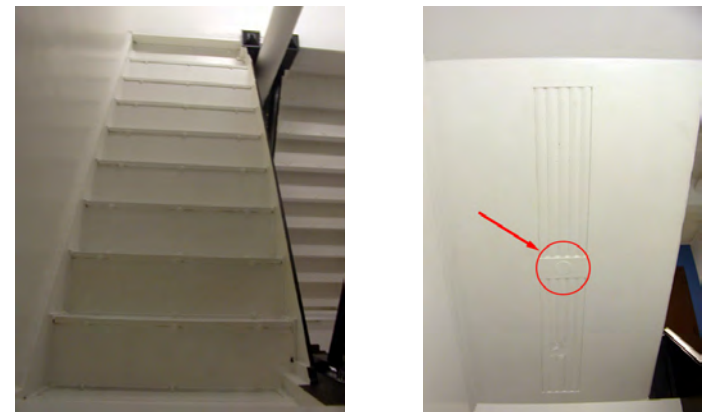
East stairway – original stair underside (left); 1930s stair underside with previous fixture location (right).
