COLUMBIA COLLEGE CHICAGO  
CAMPUS PRESERVATION PLAN

Volume VI

624 SOUTH MICHIGAN AVENUE

Submitted by  
McGuire Igleski & Associates, Inc.

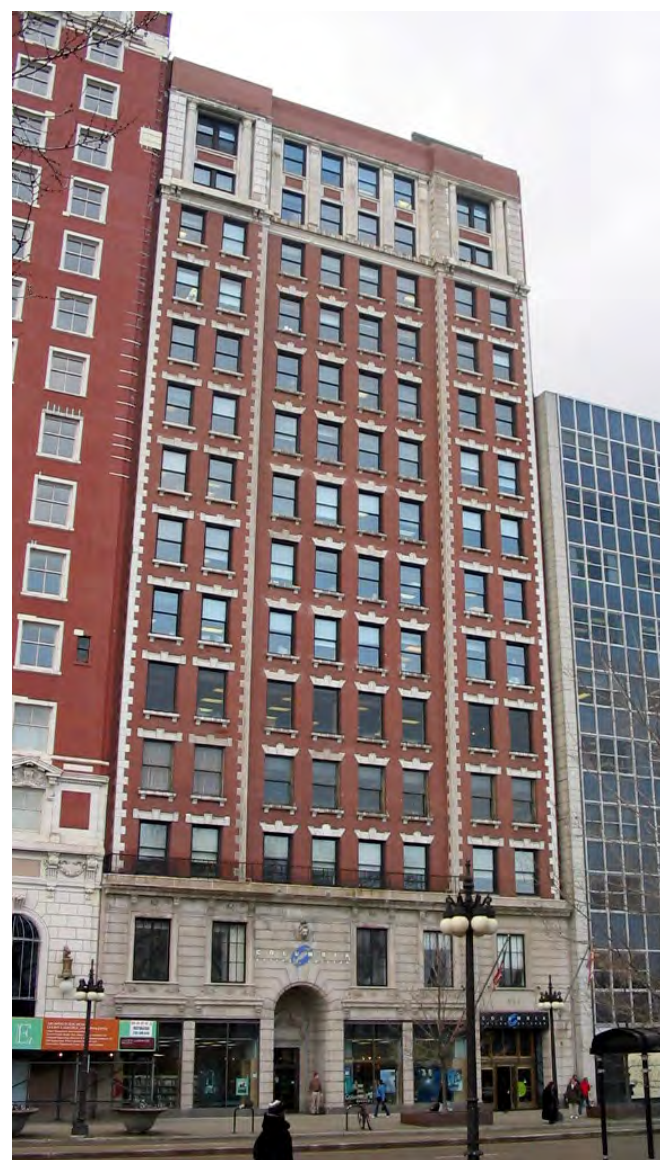
*Primary façade, facing east*

The cornice was originally ornamented with “end pavilions” over the windows of the outer bays, since removed. These consisted of terra cotta broken-segmental pediments with terra cotta urns embellished with cascading floral ornament. The cornice detail also included egg-and-dart motif, dentils and laurel leaf wreaths. The windows on the thirteenth floor had terra cotta balustrades. The ornament has been removed and the parapet wall is brick capped with limestone.

As a building that is a contributing resource to the City of Chicago's Historic Michigan Boulevard Landmark District, and eligible for listing on the National Register, the character and qualities of the 624 Michigan Campus Building should be maintained and preserved as the highest priority. The continued preservation of the exterior character of the building includes preserving its design, scale, materials and ornament. Work should be undertaken with the highest consideration to preserving the historic design and materials, and new work or repair should be completed in a manner sympathetic to the historic character of the building. Restoration of the missing cornice would improve the

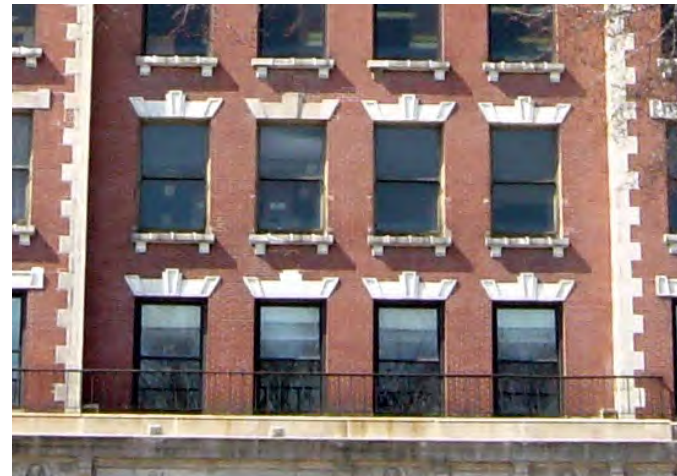
*Detail of quoins and window ornament*

The windows on the upper floors are mostly aluminum double hung replacements. The fifth floor windows have been replaced with single sash, fixed units that have tinted glass. The only remaining wood double hung windows are on the fourth floor, although they are not original. Historic photographic documentation shows the original wood windows were a six-over-one light configuration. Additionally, there were window railings at the outer two bays, on alternate floors between the third story

and the thirteenth story. The windows are detailed with terra cotta flat arches and sills supported by decorative brackets. Some original terra cotta lintels and quoins have been replaced in limestone. The terra cotta wall surface and ornament is in fair condition with some cracks.

- Continue regular façade inspections and maintenance.
- Repair terra cotta wall cladding, window lintels and sills. If too deteriorated to repair, replacement in kind is recommended for replacements. Routine maintenance of the brick includes appropriate tuckpointing as needed.

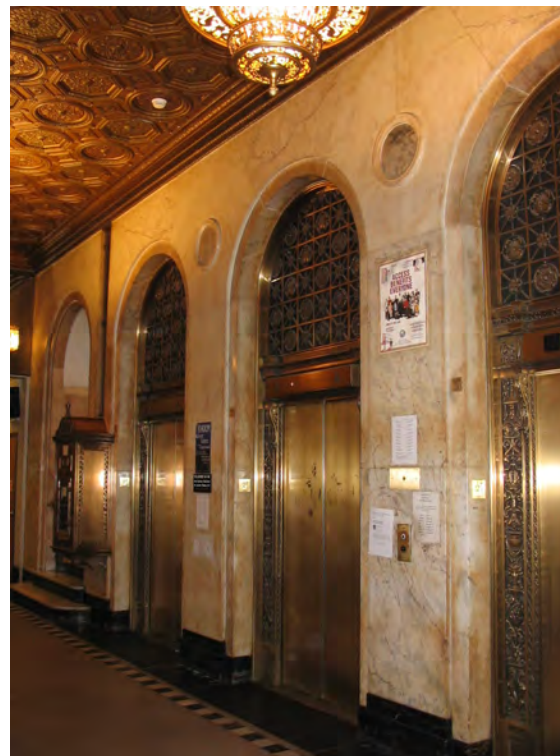
is located at the south wall. The floor of Tennessee marble is a beige colored field surrounded by a two tiered marble border: the inner border having black and beige squares, and a solid black outer border. There are areas of damage that include holes created for installing conduit and areas where concrete patching material has been applied.

*View of elevator lobby*

- Repair marble floor in Elevator Lobby.
- Restore marble walls and floor of Entrance Vestibule. This includes removing the mirrors on the walls and the carpet from the floor. Repair marble as needed including infill at former stair to basement level and repairs at door thresholds.
- Repair marble walls between elevators. Remove current patch material, clean and patch using a well matched, permanent Dutchman repair.
- Clean all marble surfaces.
- Clean painted plaster ceiling. Do not repaint.
- Organize and locate the newspaper boxes, free standing signage and other containers to minimize a cluttered appearance.

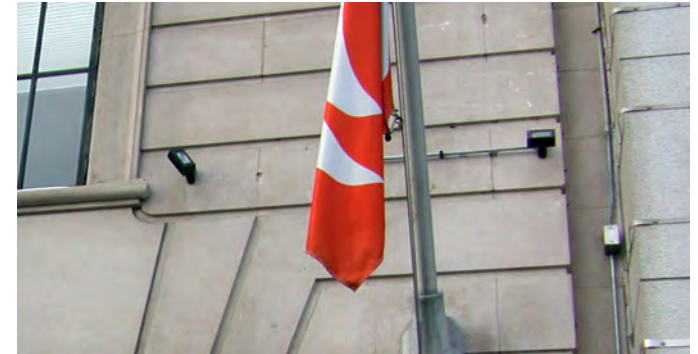
East elevation – floodlights and exposed conduit.

- The black floodlights and exposed electrical conduit are not integrated within the architecture. These fixtures should be removed and a new lighting scheme, integrated with the building or nearby street lighting poles, should be designed.
- The existing HID downlight should be removed and replaced with a new fixture that replicates the original lantern. All efforts should be made to recreate the original fixture with regard to detailing, materials and finishes.

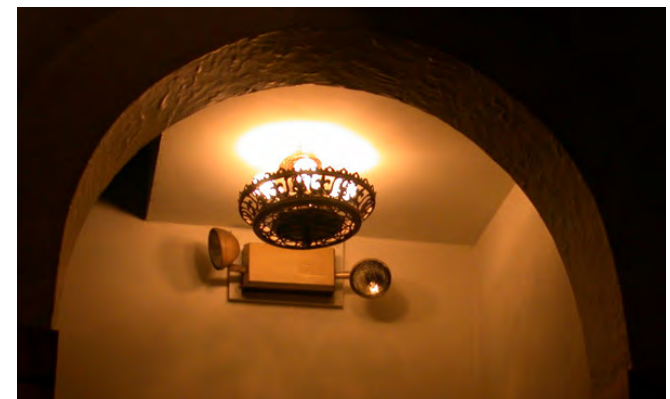
Main stairway – chandelier and emergency light.

- The jelly jar-style sconces in the stairway should be removed and replaced with fixtures more sensitive to the architectural character of the building.
- If permissible by code, the battery-powered emergency units and exposed conduit should be removed. New emergency lighting should be provided through emergency circuits in existing light fixtures.

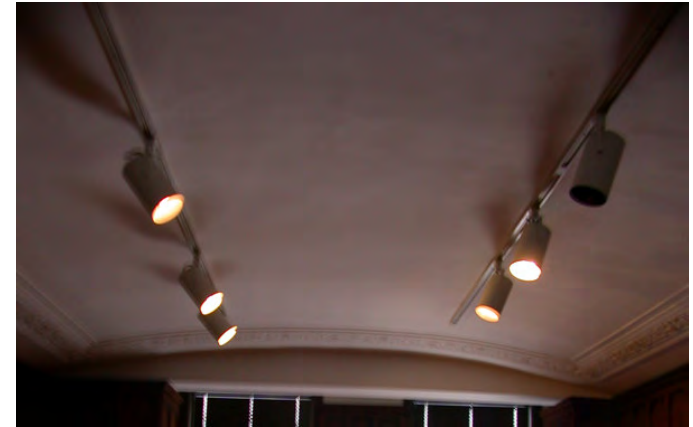
Conference room – track lights.

- The existing track and torchieres should be removed and replaced with a lighting system that is more sensitive to the architectural character of the space. Since the function of the room is significantly different than that for which it was originally designed, every effort should be made to minimize the impact and visibility of any new, non-historic lighting.
