COLUMBIA COLLEGE CHICAGO  
CAMPUS PRESERVATION PLAN

Volume VII

1014 SOUTH MICHIGAN AVENUE

Submitted by  
McGuire Igleski & Associates, Inc.

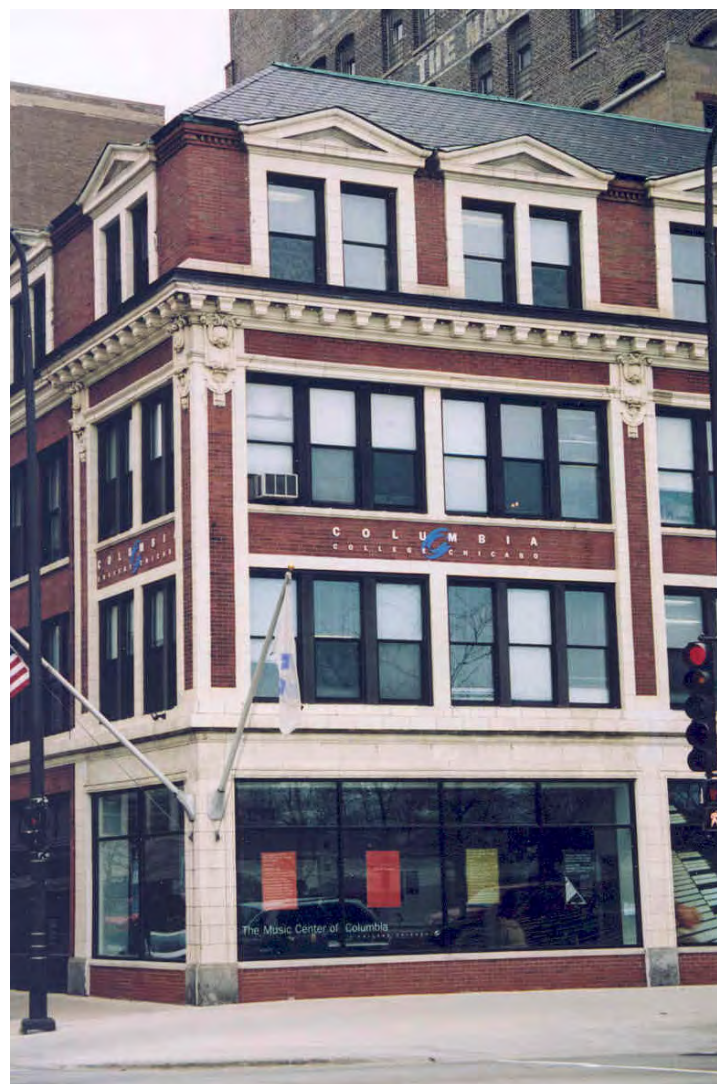
*Exterior façade at the southeast corner*

The terra cotta elements are in good to fair condition, with some cracks, spalls, and displaced units. There are non-matching replacement units and patched units. Damaged terra cotta at window lintels is an indication of steel corrosion; other cracking may be a result of differential settlement. The terra cotta deterioration appears to have been routinely maintained for the short term.

- Conduct a comprehensive façade inspection to identify problem areas and design a program for terra cotta and brick repair. Conduct comprehensive terra cotta and brick façade restoration including repair and replacement of deteriorated terra cotta and anchors; tuckpointing with an appropriate mortar; and new sealants at wash joints and windows. Maintain granite wall base by performing routine inspections to locate and correct causes of deterioration.

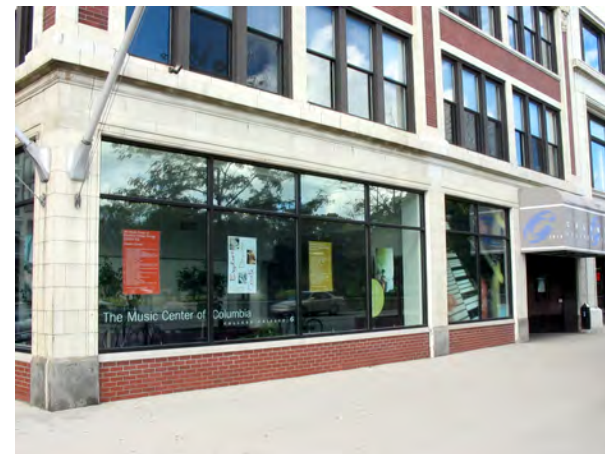
Storefronts and transoms have been replaced with aluminum on the Michigan Avenue elevation and first bay of the 11<sup>th</sup> Street elevation. The upper stories have double hung aluminum replacement windows. The period of significance for this building is 1946-47 when it was altered to its current configuration. The renovation included extensive interior alterations to all four floors, a new mansard roof configuration, and a new Michigan Avenue entrance and lobby. The original roof had a less steeply angled slope, roof cresting, and pedimented dormers without the brick walls. Although the windows, storefronts and main entrance have been replaced since the 1940s remodeling, the facades retain a high degree of integrity relative to its period of significance.

*East façade storefront windows*

- Maintain the cast iron store fronts with paint.
- Entrance awnings should be of a design that is more historically appropriate.
- When replacement of the non-original windows or storefronts is considered, the new units should reflect the appearance of the original. This work should be done based on available historic documentation and should incorporate restoration of both materials and design.

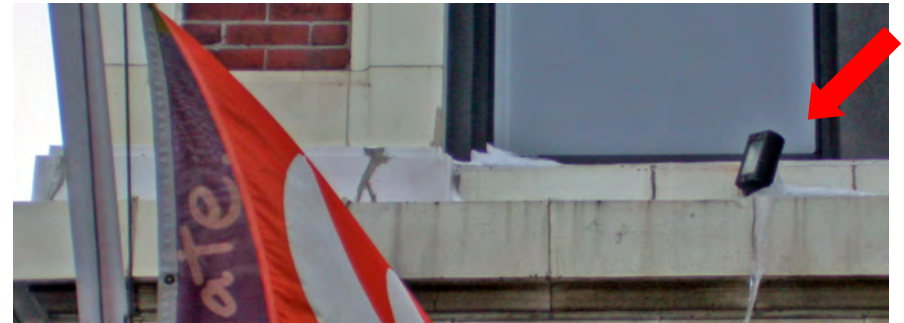
- The floodlights, though small, are finished in black and are not integrated within the architecture. If desired, new lighting should be designed that better integrates with the building or nearby street lighting poles.
- The fluorescent striplights and their associated exposed conduit behind the awning are large and conspicuous. Fixtures should be replaced with smaller, better concealed fixtures, which can illuminate the entryway and not attract attention to themselves.

East elevation – floodlight.

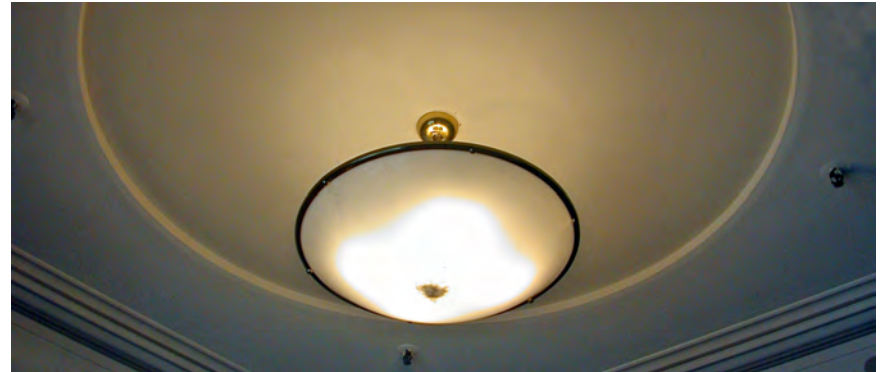
Entrance lobby – main pendant.

- The fixtures currently lighting the lobby should be removed and replaced with fixtures in the original locations. Every

effort should be made to install fixtures sensitive to the original architecture.

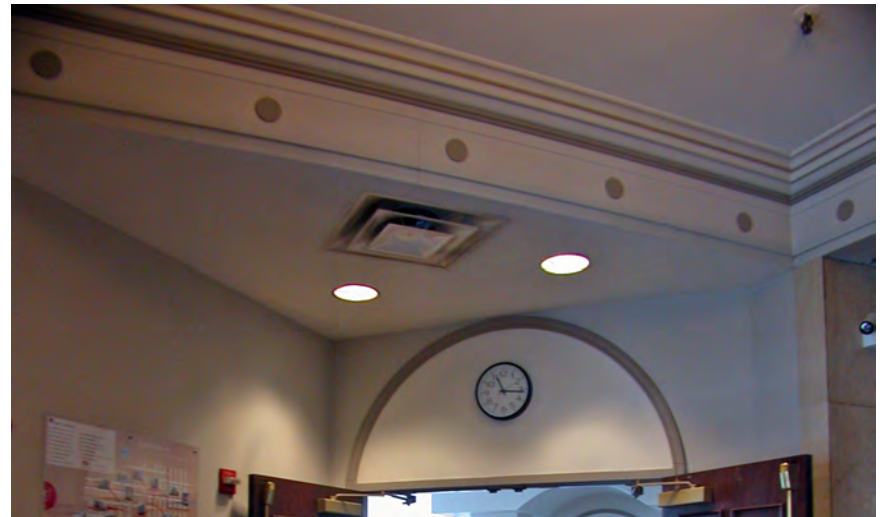
Entrance lobby – downlights added to dropped ceiling.

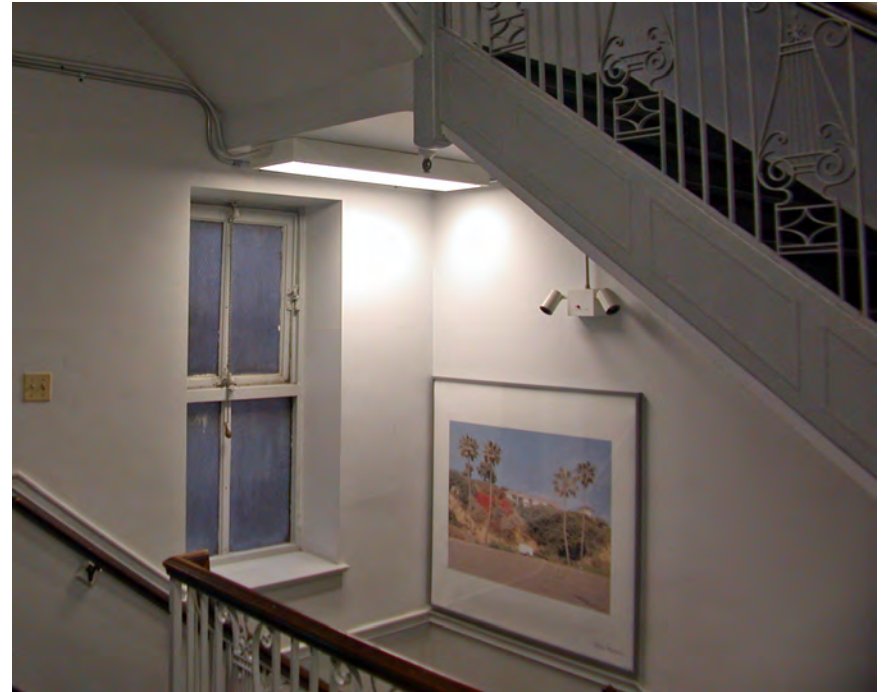
Main stairway – fixtures and exposed conduit.

- The surface-mounted fluorescent fixtures in the stairwell should be replaced with fixtures in the original locations, and all exposed conduit should be removed. New fixtures should be sympathetic to the original architecture.
- New, historic fixtures may need to be supplemented with additional functional lighting, though the appearance of any of these fixtures should be minimized.
- If permissible by code, battery-powered emergency units should be removed. New emergency lighting should be provided through emergency circuits in existing light fixtures.

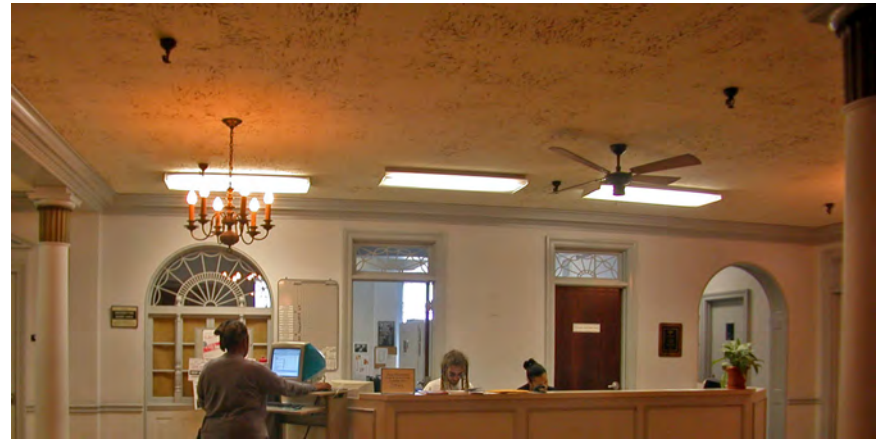
Third floor lobby – fluorescent wraparounds and incandescent chandeliers.

- In the third floor lobby, the current light fixtures should be removed. Replacement fixtures should be installed in the original locations, as shown in the drawings, and every effort should be made to be sensitive to the original design.

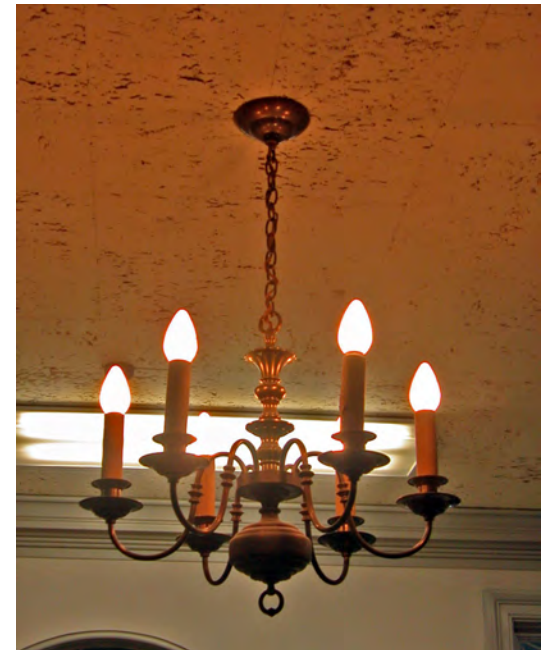
Third floor lobby – incandescent chandelier.

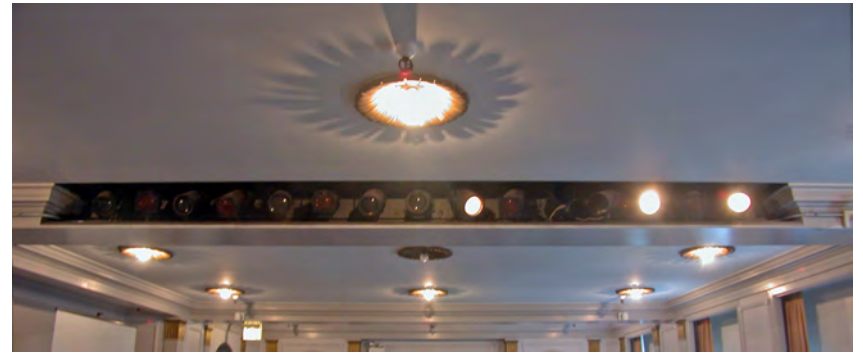
Recital hall – “flower” lights and concealed stage lighting.

- As the current lighting appears to be original, effort should be taken to preserve it. Concealed stage lighting fixtures and socket strips may be replaced as necessary, but their replacements should not be more visible than the originals.
- The current A lamps in the “flower” fixtures appear to be too small for the scale of the plaster ornamentation. These should be relamped with larger G (globe) lamps, which were likely the type of lamps used originally.
- All original light fixtures should be professionally cleaned and refurbished. In addition, they should be re-wired to comply with current the electrical and building codes.
