COLUMBIA COLLEGE CHICAGO
CAMPUS PRESERVATION PLAN

Volume VIII

1306 SOUTH MICHIGAN AVENUE

Submitted by
McGuire Igleski & Associates, Inc.

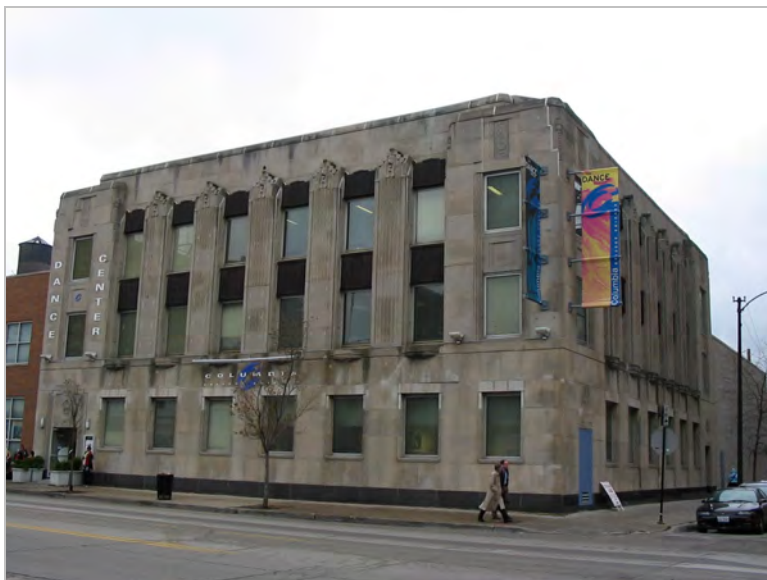
East and west facades viewed from Michigan Avenue

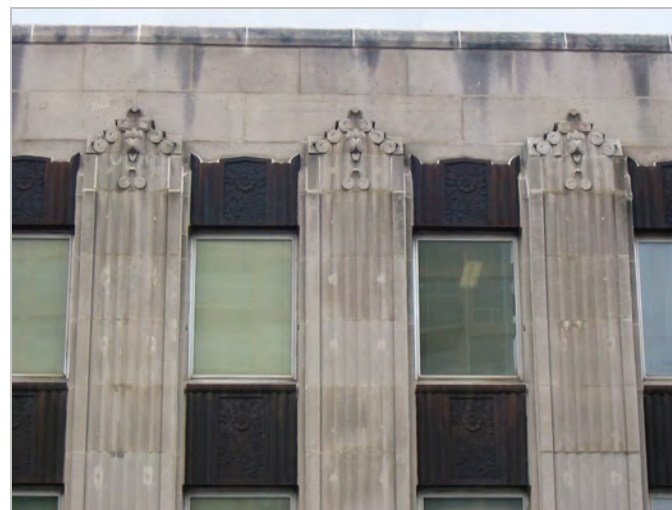
Detail of stone and metal ornament at third floor

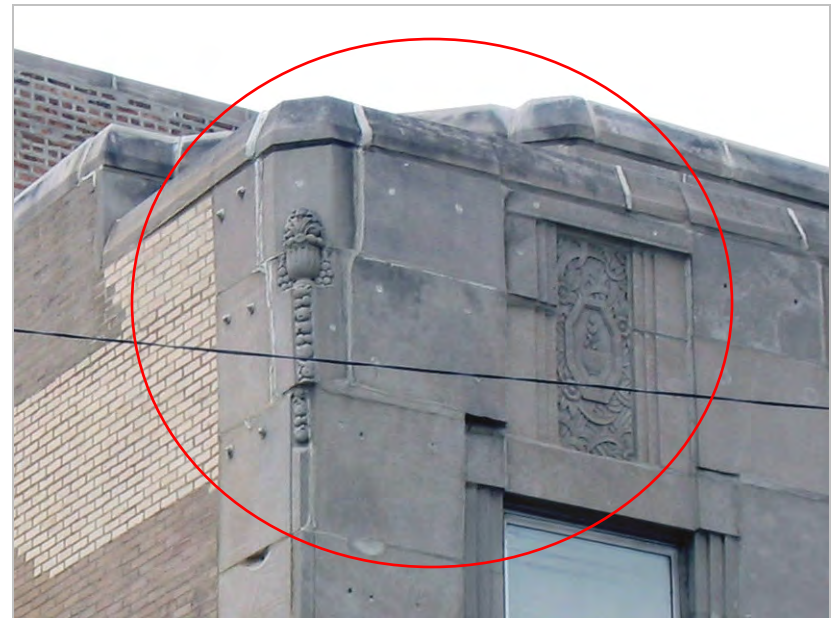
Deterioration of the limestone includes spalling and displacement of the stone. The spalls - most of which have been patched- are caused by corroding anchors. Displaced stone at the top of each corner bay and at the pier caps between the windows has been stabilized with pins. Pinning has also been used to stabilize the parapet wall, which is bowed at the east façade and leaning toward the building at the north façade. This pinning is a temporary repair.

Detail of southeast corner showing displaced stone

- Conduct a comprehensive façade inspection to identify problem areas and design a program for repair. Inspect the limestone to locate causes of deterioration and reasons for displacement. Implement a permanent solution for the displaced stone (primarily at the corners) and leaning parapet.

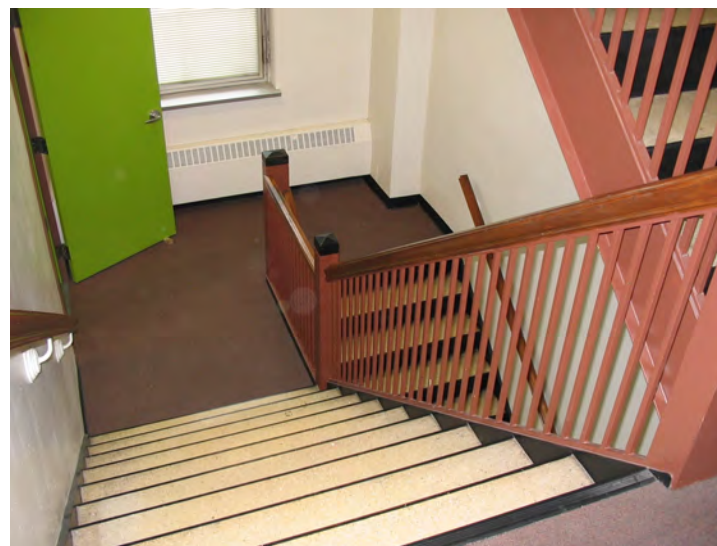
Main stair from intermediate landing

Some finishes and surfaces of the stairway have been covered with non-original material, including acoustical tile over the ceilings, carpet over most landings and wallpaper, which is now painted, over some walls. Other non-original elements include the aluminum window sills and baseboard heaters. However, with only minor and generally reversible

The terrazzo, plaster walls, wood handrail (including finish), and metal elements should be preserved or restored. With the exception of the plaster walls, these elements appear to be in good condition, requiring only routine maintenance.

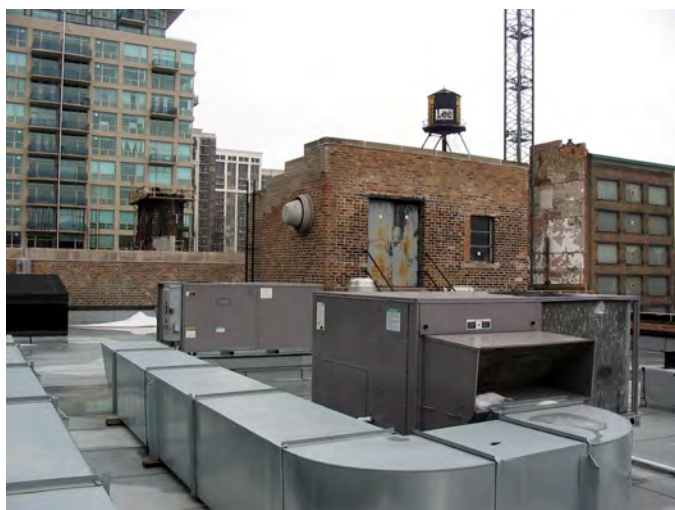
View of roof and elevator penthouse looking southeast

The roof includes the elevator penthouse near the southeast corner of the original building and the stair penthouse and adjacent chimney at the northwest corner. The walls of the elevator penthouse are of common brick with limestone coping. The walls of the stair penthouse have been partially rebuilt using new face brick with metal coping. The

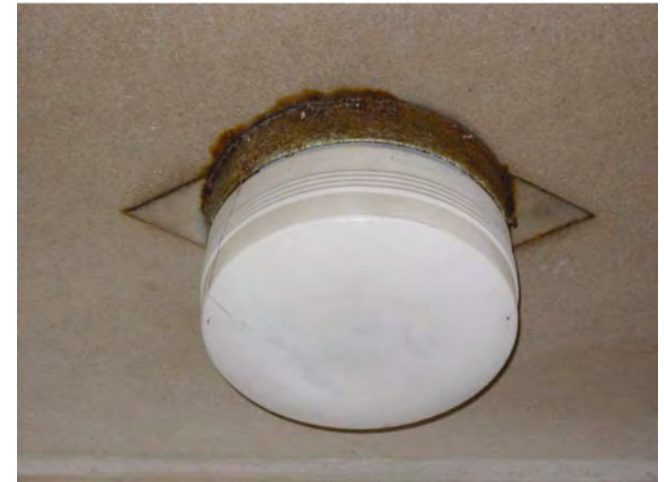
The fixture above the northwest doorway is heavily corroded, and the glass lens appears to be broken.

Northwest corner – existing original light fixture.

- The fixture above the northwest doorway is heavily corroded, and the glass lens appears to be broken. If possible, the fixture should be restored to its original condition; otherwise, a replica using the original materials should be made. If the northeast doorway, which is

currently boarded up, is to be restored, another replica should be made for installation in that location.

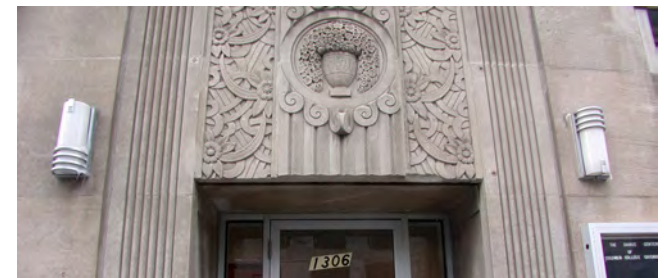
Main entry – sconces.

- The sconces flanking the main entry appear to be in the proper locations, although the style and materials do not match the building itself. One of the sconces, most likely the one to the north, is upside down. These sconces should be replaced with new fixtures more sympathetic to the materials and style of the Art Deco architecture.
- The HID floodlights, mounted at the north and south bays and center of the east façade, and the fluorescent floodlights, at the façade's center, are a significant intrusion on the architecture of the building. These fixtures, as well as the exposed electrical conduit feeding them, should be removed. If desired, they should be replaced with a lighting system that is more carefully integrated into the architecture or an adjacent street lighting pole.

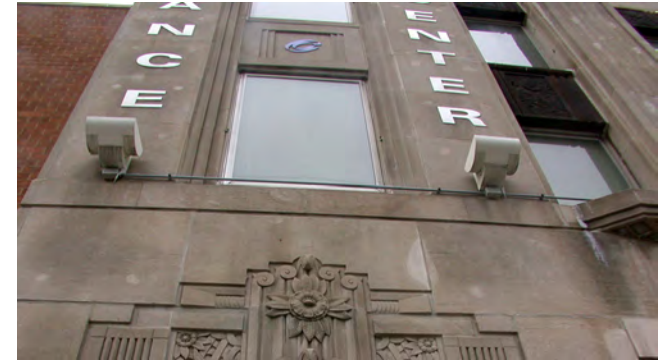
East façade – HID floodlights.

- The HID floodlights, mounted at the north and south bays and center of the east façade, and the fluorescent floodlights, at the façade's center, are a significant intrusion on the architecture of the building. These fixtures, as well as the exposed electrical conduit feeding them, should be removed. If desired, they should be replaced with a lighting system that is more carefully integrated into the architecture or an adjacent street lighting pole.

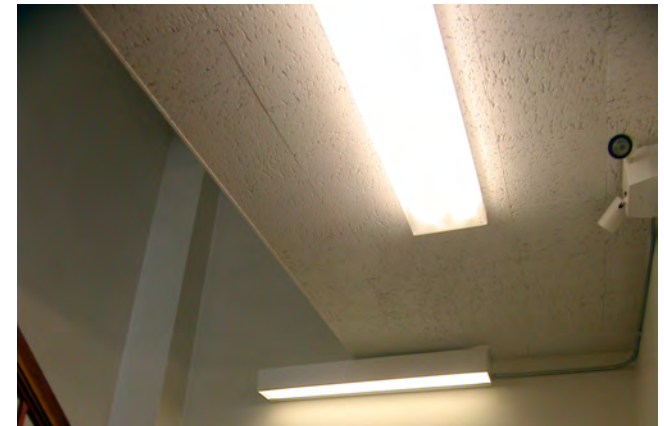
The main stairway of the Dance Center is currently illuminated with a series of lensed fluorescent fixtures, the majority of which are mounted to a new acoustical tile ceiling. The combination of new ceiling and wall coverings has disguised any evidence of previous fixture types and locations. The location of windows suggests that all stairway lighting fixtures were located on the ceilings above each landing.

Main stairway – lensed fluorescent fixtures and emergency "wall pack".

- The linear fluorescent fixtures, as well as any exposed conduit, should be replaced with a more architecturally sensitive solution. Any replacement lighting fixtures should reflect the design and materials of the original building. Providing fixtures that match the aesthetic of the architecture would be a significant step toward restoring the integrity of this space.
- If permissible by code, emergency lighting “wall packs” should be eliminated, instead providing egress lighting through existing fixtures.

Recommendations: With no historical reference materials to direct any preservation work, any changes to the lighting should be sympathetic to the existing architecture. If, in the

process of any construction within the stairway, evidence of historical lighting fixtures is discovered, that information should be used as a guide for further preservation work.
