COLUMBIA COLLEGE CHICAGO
CAMPUS PRESERVATION PLAN

Volume IX

731 SOUTH PLYMOUTH COURT

Submitted by
McGuire Igleski & Associates, Inc.

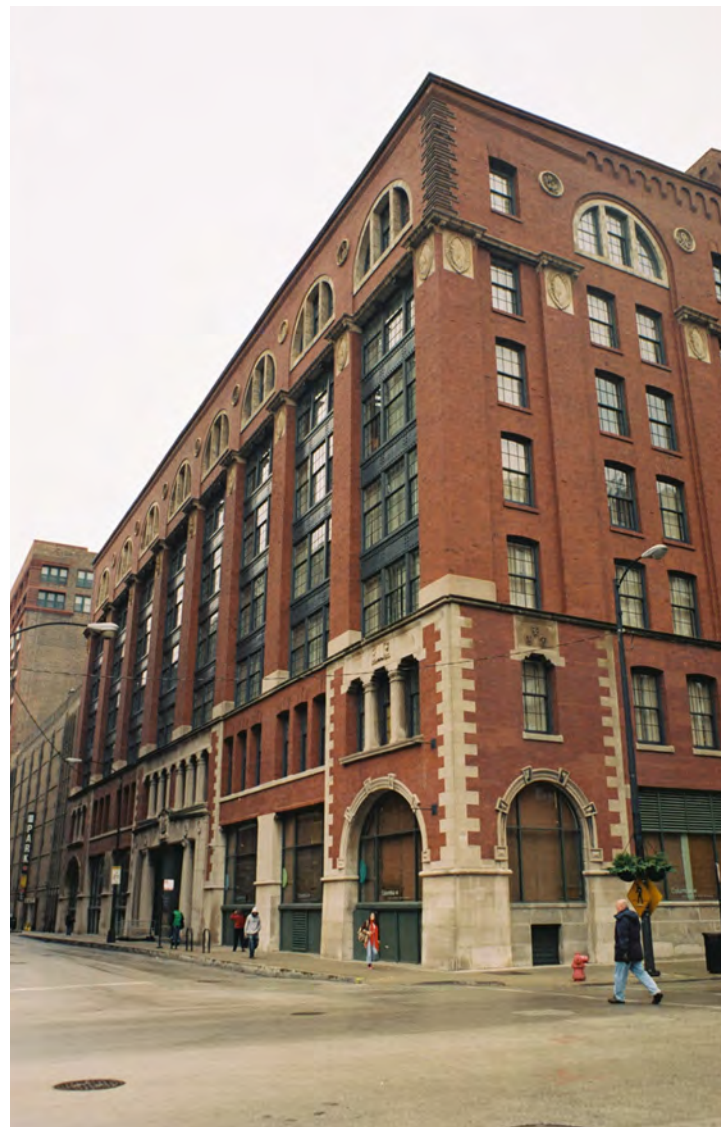
West façade

The west elevation, located on Plymouth Court, is divided into eight bays of equal width which are separated by brick piers. The main entrance is located within a limestone recess and spans the center two bays at the base of this facade. The two sets of replacement double doors are flanked by original squared Doric columns. The entrance bays as well as the corner bays are trimmed with limestone quoins and have simple limestone columns and lintels framing the second floor windows. The windows on the first floor at the outer bays are located within arches while the remaining four bays are storefronts. All of these windows are aluminum replacements.

The glazed terra cotta cornice, wall ornament and wall trim have some cracks and spalls. The first floor red terra cotta lintels and sills have some cracks.

The brick wall surface was observed as having some spalling and inappropriate patch repairs. The brick quoins at the seventh floor are deteriorated. This is a distinctive feature of the brick masonry that should be maintained to avoid loss of historic fabric.

The limestone wall surface and ornament has some cracks and spalls. Some of the damaged limestone has been poorly and insensitively patched. The carved stone wall ornament has some cracks and spalls, observed in particular, near the entry.

- Continue regular façade inspections and maintenance.
- Conduct inspection of the cornice and repair as necessary. Inspect the terra cotta for cracks and deteriorated anchors. Repair and tuckpoint.
- Maintain cast iron ornament and spandrels. Protect with paint.
- Maintain brick and perform appropriate tuckpointing as

- Restore deteriorated brick quoins and maintain with appropriate tuckpointing as needed.
- Restore the damaged limestone with appropriate repairs. Maintain by performing routine inspections for deteriorated anchors, repair and tuckpoint as needed.

- Repair the carved stone wall ornament. Maintain by performing routine inspections to locate and correct causes of deterioration.
- Replace damaged wood brick mold. Maintain all wood elements with paint.

- Avoid contact with detrimental deicing salts that can damage the wall surfaces and the granite floor.
- Returning the ground floor windows to the historic configuration will improve the integrity of the primary facades. This work should be done based on available historic documentation and replicate the original design and materials.

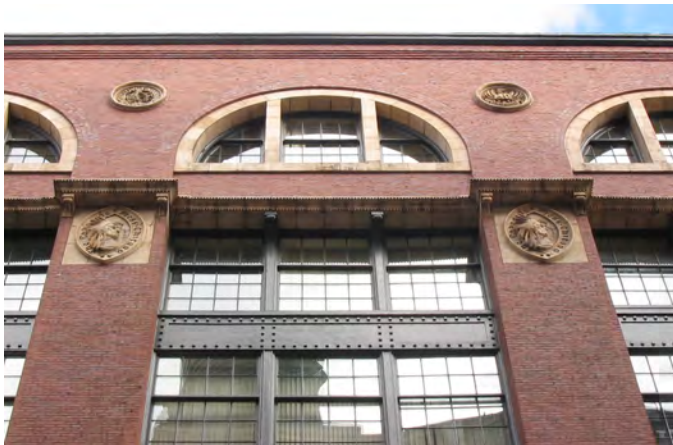
Windows at shaft and capital of building on the west elevation

Each bay on floors three through six has three grouped double-hung windows. These are replacement wood windows with an 8 over 12 light configuration achieved with applied muntins, some of which are deteriorating and falling off the windows. Metal industrial spandrels between each floor separate the sets of windows. Each bay on the west elevation has an arch on the seventh floor, creating an arcade of windows across the facade.

- When replacement of non-original windows is considered, restore to their historic appearance. The windows are an important design element and any proposed program should be based on evidence of the original and should incorporate restoration of both materials and design. Do not use applied muntins.

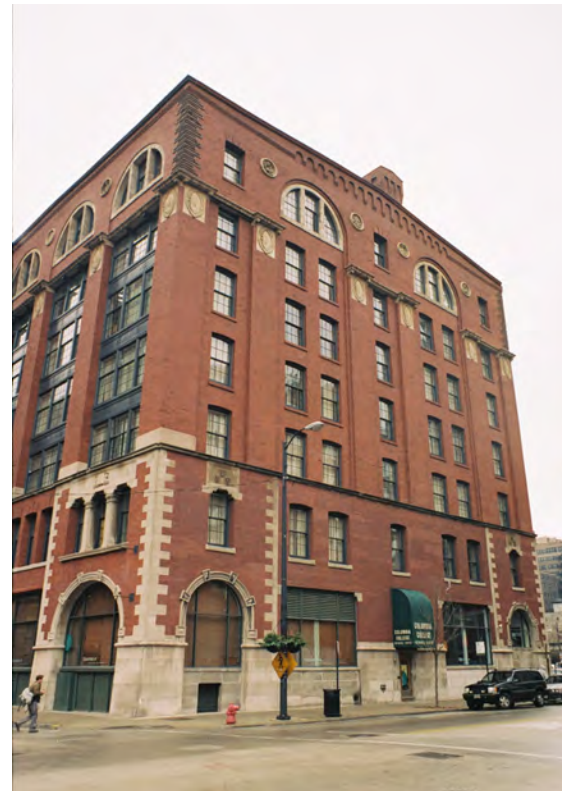
South façade

The south elevation includes five bays that follow an A-B-A-B-A configuration with one double-hung window for the A repetition and with two double-hung windows for the B repetition. The base of the south façade also follows the A-B-A-B-A configuration with large commercial store front windows at the two large bays, two arched window openings at the outer bays, and at the center bay, an original window opening has been converted to a door opening. The upper windows on the south

façade have been replaced with wood windows with a 6 over 6 light configuration achieved with applied muntins, some of which are deteriorating and falling off. The original windows at the base have been replaced with aluminum storefronts. The outer two bays of the south elevation are trimmed with limestone quoins. Two arched window openings, like those on the west façade, are located on the seventh floor at each wide bay.

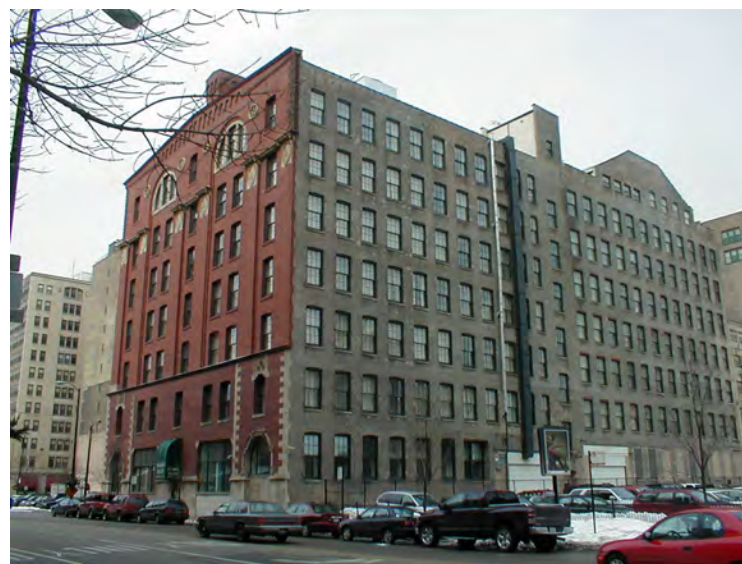
East façade

A simple window organization on the east elevation is only broken with two vertical sets of windows which express the stairway on the interior of the building. Almost all windows on the east façade have been replaced with wood double-hung windows with a 6 over 6 light configuration achieved with applied muntins. On the north side of the east façade all first floor window and door openings are filled in with common brick. Running the full height of the east elevation is the exhaust pipe from the code-required emergency generator in the basement. A kitchen exhaust duct runs from first floor to a roof-mounted fan, and there are ventilation openings on the lower levels of the east elevation.

- Inspect the terra cotta lintels regularly to identify areas of failure for repair. Continue regular façade inspections and maintenance.
- Maintain wood elements with regular paint application.

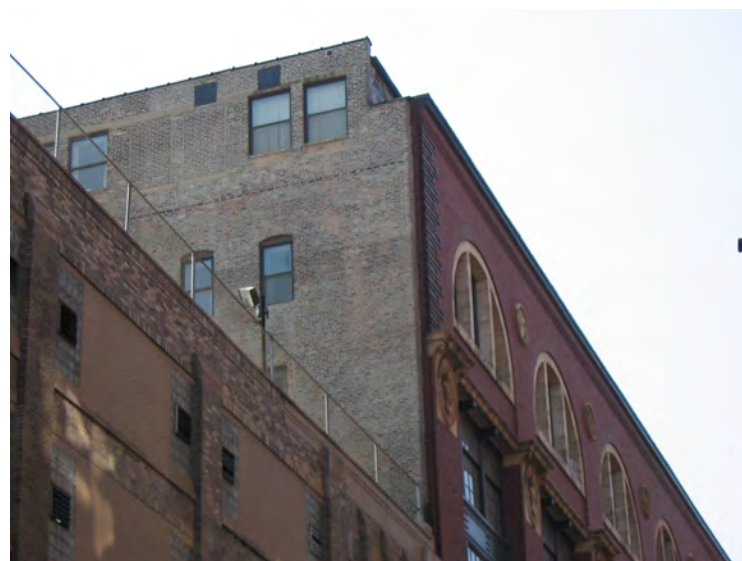
Northwest corner of the upper levels including the penthouse level

The top floors and penthouse of the north elevation are the only floors exposed as a neighboring building abuts the dormitory up to its sixth floor. All windows were replaced with aluminum double-hung windows.

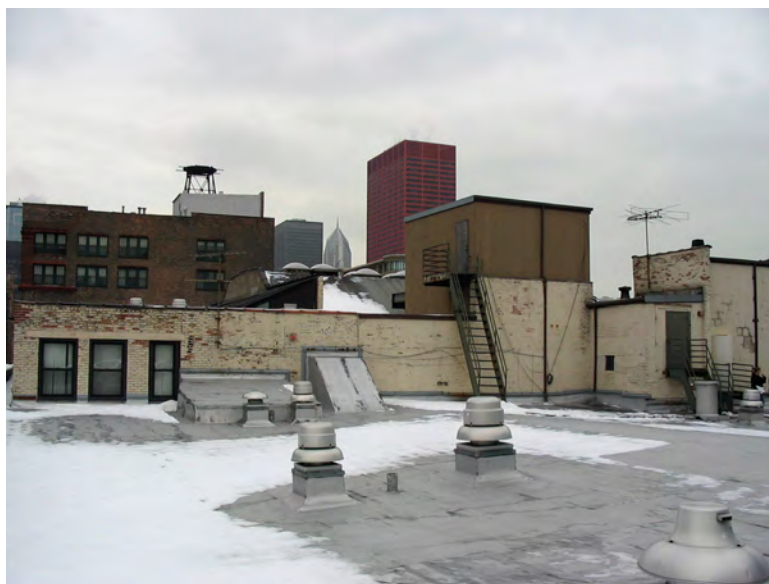
View of Roof looking north

The Columbia College Dormitory has a flat, bituminous built-up roof. The parapet walls are brick with metal coping on the west wall and clay tile coping on the remaining walls. At the south end, in the center, is a brick chimney. The lower portion of the chimney is constructed of common brick; the upper portion is red face brick with brick corbelling. This finish detail compliments the south façade from which it is visible. Clay tile coping terminates this chimney.

There is severe brick damage on the backside of the west parapet between the top of the base flashing and the drip edge on the coping. Prolonged infiltration could result in deterioration to the face brick on the front of the parapet.

- Repair the brick damage on the west parapet. Deteriorated brick should be replaced with compatible material and appropriate tuckpointing completed as needed.
- Continue regular inspection of the clay tile coping on the parapet to identify and repair broken pieces. Ensure the joints are properly sealed.
- Maintain the brick and clay tile on the chimney including proper tuckpointing as needed.

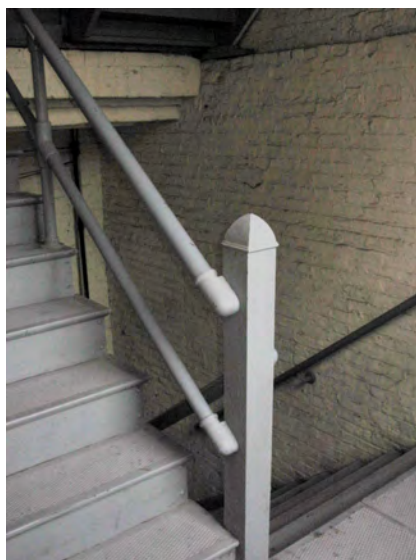
The East Stairway is located near the center of the building with an adjacent freight elevator, and shares an exterior common brick wall and wood double-hung windows with the east façade. The stairwell has a U stair configuration which runs the full height of the building. The stair structure is metal with pipe railings and simple metal newel posts. The side walls of the stair are made of common brick which transitions into clay tile toward the top of the stairwell. The ceilings at each floor landing are formed by the arched floor structure and are finished in plaster. A decorative metal grille is located on the north wall of the stairwell.

- The original medallion-shaped balusters have been removed. Restoring these would greatly enhance the stair.
- Restore the stain finish to the wood railing. In lieu of that, the current paint finish should be maintained.
- There should be continued preservation of historic materials and configuration.

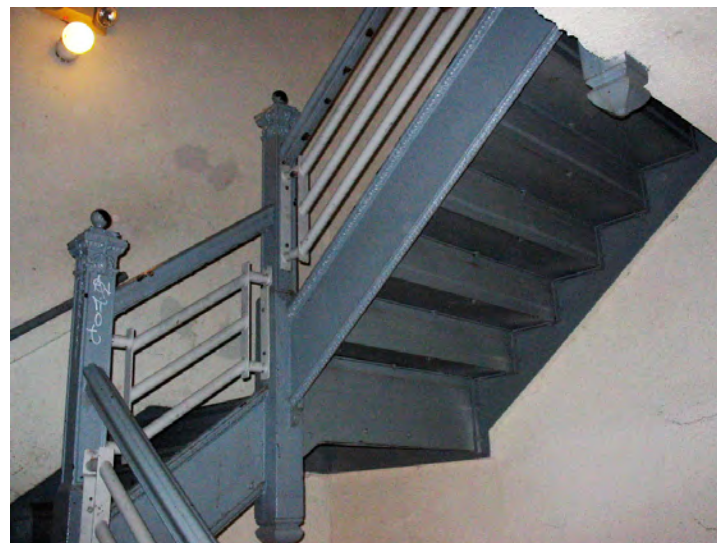
The West Stairway is located in the center of the building. The stairs are accessed by a side hallway. Four landings occupy each corner of the stairwell and steps are located adjacent to each of the four walls. The stair structure is of cast iron. The stringers have detailed ornamental trim along their top and bottom edge. Detailed ornament is also found on the cast iron newel posts. Wood railings are simple, and like the rest of the stair, have been painted. The original balustrades have been removed and were replaced with steel pipe guard rails.

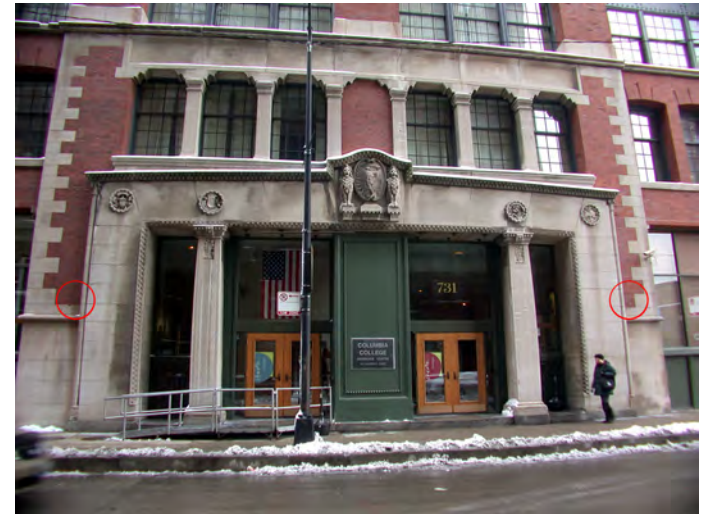
West entry – possible sconce locations marked.

- The sconce at the south entry appears to have been installed to address security concerns at that door. Replacing that fixture with either one or a pair of sconces sympathetic to the building's architecture would be a step closer to restoring the

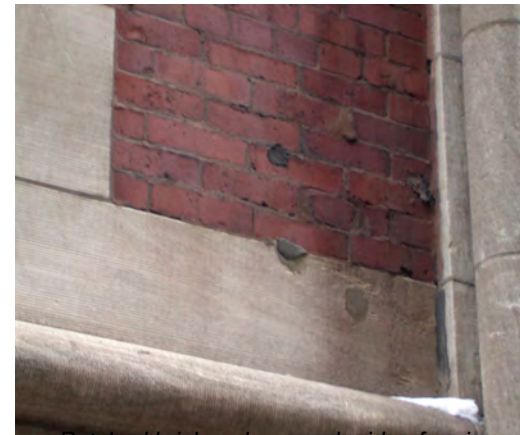
Patched brickwork on each side of main entry.
