**COLUMBIA COLLEGE CHICAGO
CAMPUS PRESERVATION PLAN**

Volume X

623 SOUTH WABASH AVENUE

June 2005

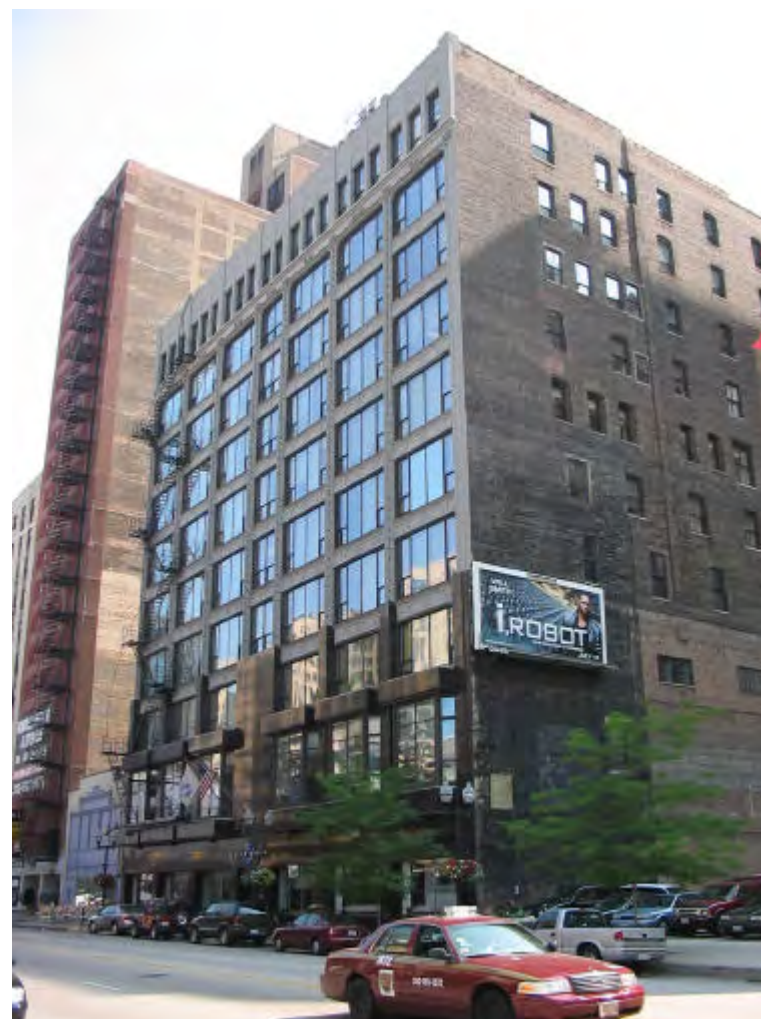
Primary exterior façade, facing west

The glazed terra cotta wall surfaces are in fair condition with some cracks and spalls.

flanked with narrower operable sash. The narrow center bay has two windows with operable lower sash. The second floor projecting bays originally had Chicago Style windows with transoms. These windows have been replaced with metal and the original mullions have been clad. The ground floor has non-original, aluminum framed storefronts. The current storefront configuration is divided into two glass units to each bay. At the north end of the façade is the original fire escape. The main entrance is centrally located, consisting of a group of three contemporary aluminum and glass doors. Some original ornament at entrance transom is still visible from the interior.

Due to these extensive alterations, this façade has a low degree of integrity.

- Continue regular façade inspections and maintenance.
- Inspect the terra cotta for cracks and deteriorated anchors. Repair and tuckpoint as necessary.

- Plan for a comprehensive terra cotta façade restoration including the removal of paint and soiling; repair and replacement of deteriorated terra cotta and anchors as necessary; tuckpointing with an appropriate mortar; and new sealants at wash joints and windows.

- Remove the granite that was applied to the first three floors and restore the terra cotta at these areas to further enhance the appearance and restore the integrity of the building. Repair terra cotta, or if missing or severely damaged, material can be replicated using existing terra cotta and historic documentation as a guide.

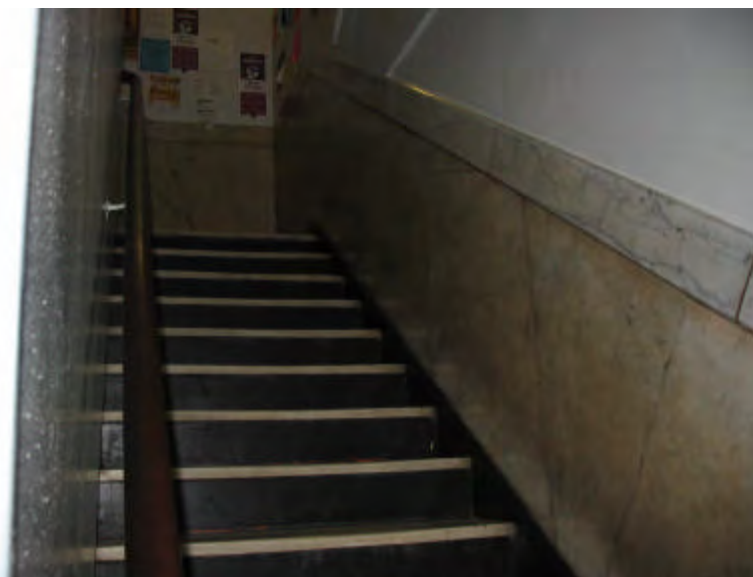
Detail of marble stair elements, floors one and two

The stairway retains a high degree of integrity.

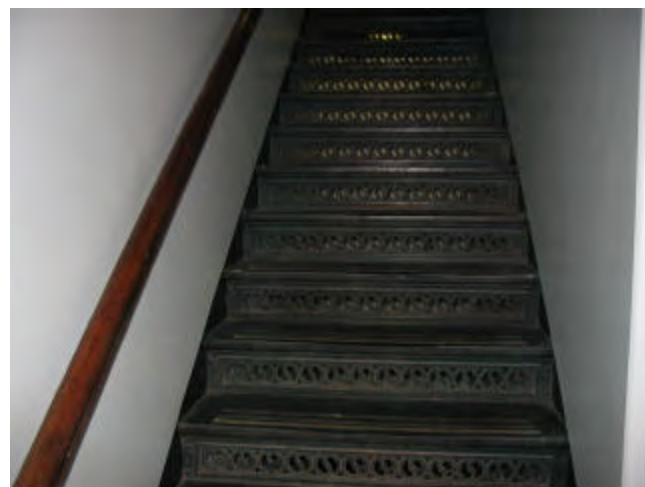
Detail of iron risers with open 'S' pattern

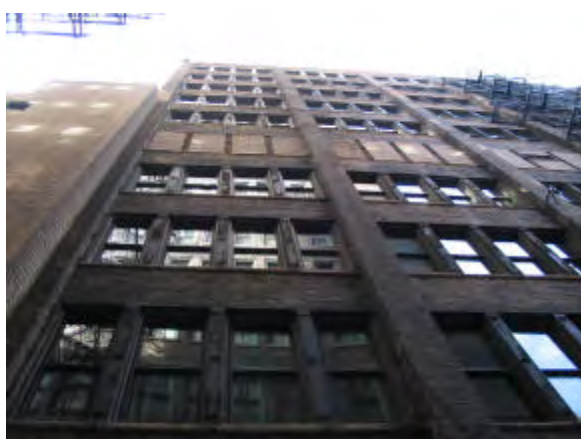
East wall detail showing window configuration

- Continue regular façade inspections and maintenance.
- Tuckpoint the brick and repair the limestone window sills as necessary. Inspect the cast iron mullions for damage and repair as necessary. Maintain with paint.

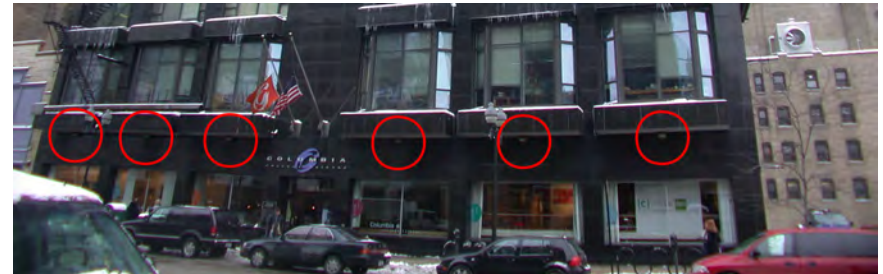
The west façade of 623 S. Wabash Avenue currently shows no signs of original exterior lighting fixtures. The only visible fixtures are a series of HID “wallpack” floodlights, located above the first floor in the center of each bay. Any evidence of previous fixtures has been covered by the new façade of black granite. *[See picture.]*

West elevation – circles indicate locations of HID “wallpacks”.

- The HID fixtures are a significant intrusion on the character of the building. Given the locations of existing lighting poles along the sidewalk, these fixtures are most likely unnecessary for pedestrian illumination and are a significant source of glare. These HID fixtures should be removed and, if desired, replaced with wall mounted fixtures replicating the original globe fixtures.
- Spot lighting could be added to accent structural features of the façade. These could possibly be concealed by the restored globe fixtures.

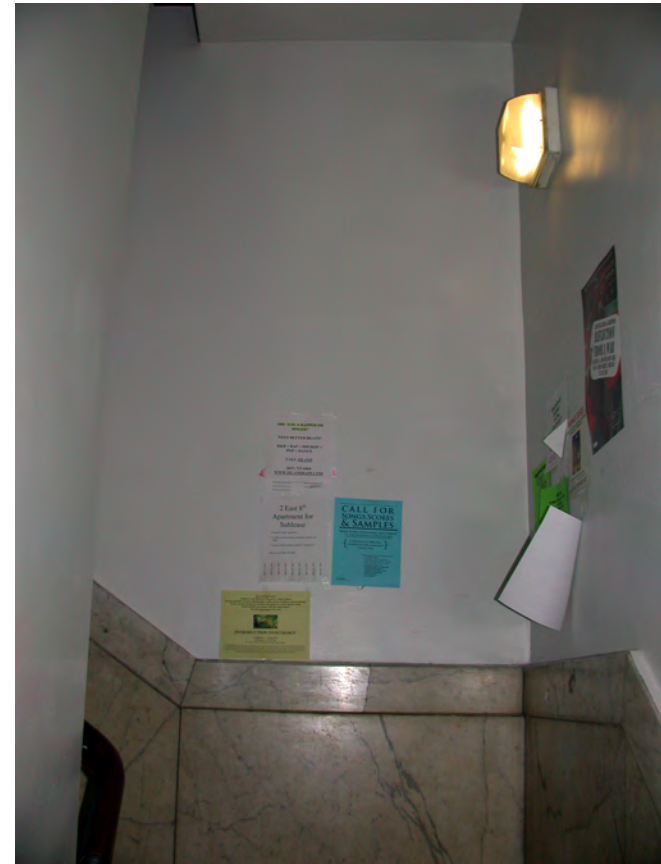
- The current fluorescent floodlights and exposed conduit are not in keeping with the style and character of the building. These should be removed and replaced with fixtures that are sympathetic to the original architecture.
- The original light fixtures in the stairwell were most likely sconces at each landing. Any new fixtures and layout should return to this type of fixture and placement.

Main stairway – typical existing fixture in main stairway.

- The current fluorescent floodlights and exposed conduit are not in keeping with the style and character of the building. These should be removed and replaced with fixtures that are sympathetic to the original architecture.
- The original light fixtures in the stairwell were most likely
