COLUMBIA COLLEGE CHICAGO
CAMPUS PRESERVATION PLAN

Volume III

72 EAST 11TH STREET

June 2005

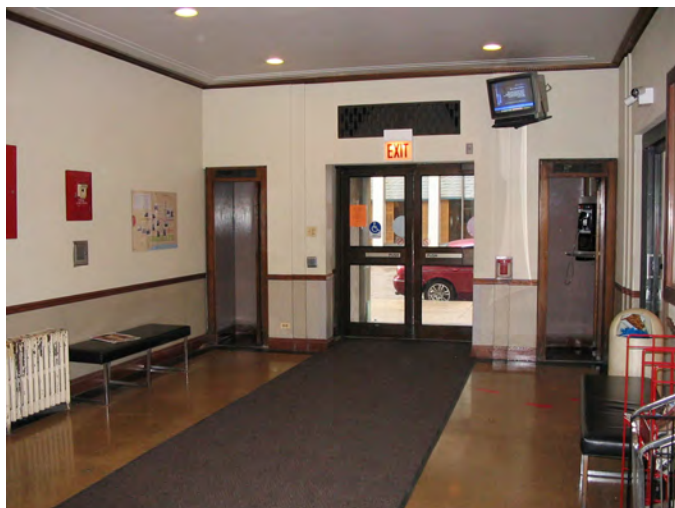
The Main Lobby is located at the east end of the building and provides access to the elevators and the Main Stairway. The lobby has a patterned terrazzo floor and a flat plaster ceiling with a chevron profile along the perimeter. The original wood paneled walls have been removed or covered with gypsum board. (The original wood cornice molding is visible beneath the gypsum.) An original metal grille remains in the wall above the main entrance. Due to alterations, the Lobby has a medium degree of integrity.

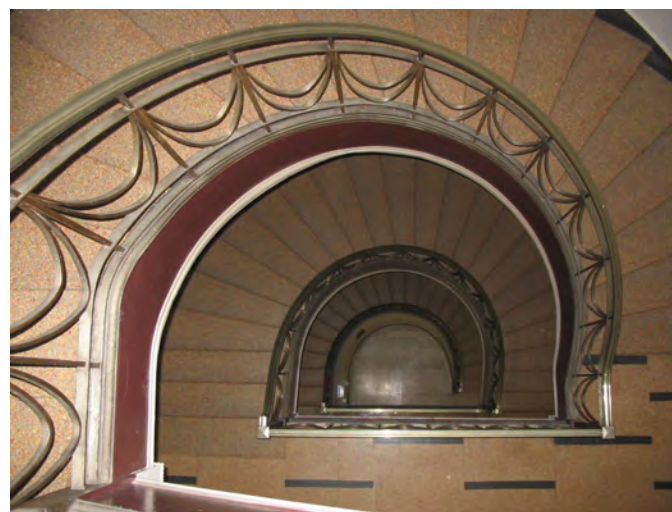
The Main Stairway is semi-circular in plan with a curved plaster outer wall and an open well. The walls, ceiling and stair soffits are of plaster. The stair treads and risers are terrazzo with black terrazzo base trim along the wall of the stair and landings. The floor of the landings is of patterned terrazzo, with grey terrazzo at the basement. A cast iron stringer panel with trim follows the inside curve of the stair. The railing consists of a metal balustrade in a swag design capped with a nickel silver handrail. A similar handrail is attached to the outside plaster wall. The Main Stairway is essentially unaltered and retains a high degree of integrity.

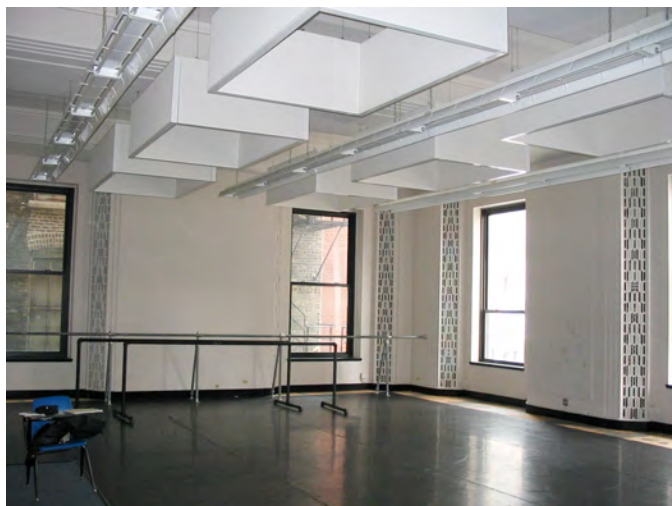
Main Dining Room (Theater Classroom 207)

The second floor Dining Room has flat plaster walls, boxed out between the windows to enclose radiators. The walls are detailed with raised

plaster panels and have canted edges, featuring ornamented, wall to ceiling grilles. Black marble is used for the wall base trim and the window stools.

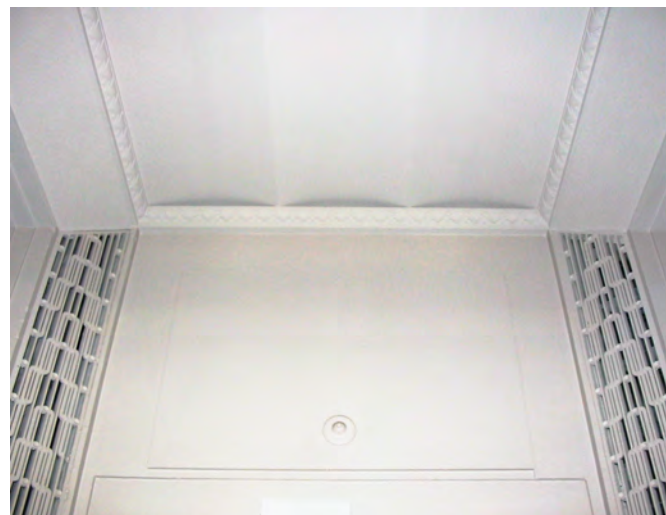
Ceiling and wall detail of Main Dining Room

The ceiling is plaster and consists of boxed beams spanning the short length of the room and scalloped surfaces in the recesses between the beams. Ornamented plaster trim runs along the edges of the beams and the perimeter of the room. The ceiling is partially obscured by suspended fluorescent light fixtures and acoustical tile baffles.

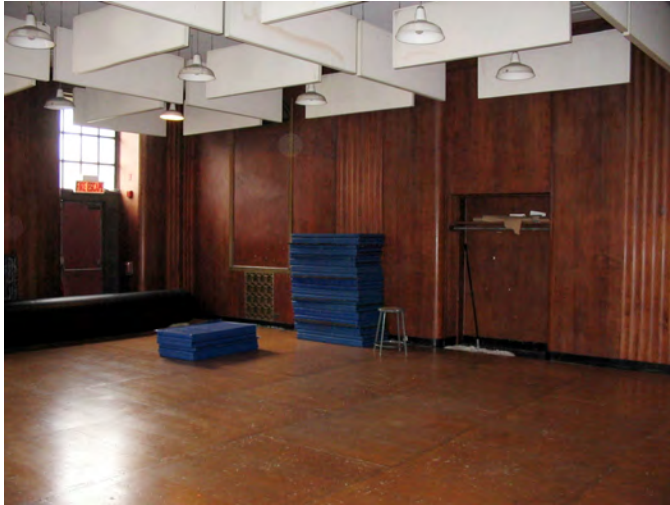
Lounge (Acting Studio 305)

The third floor Lounge has wood paneled walls with black marble base trim. The flat paneled wall surface is articulated with vertical bands of fluting at original wall sconce locations, and stepped out surfaces around the fireplace on each the east and west walls. The ceiling is of flat plaster with a stepped design around the perimeter and is partially obscured by suspended light fixtures and acoustic baffles.

Along the north wall are a series of door openings that originally opened to the Foyer. Each opening has been filled in with gypsum board to accommodate a single door. The door to the Library (307) has been removed or walled over, creating a niche that has been faux painted.

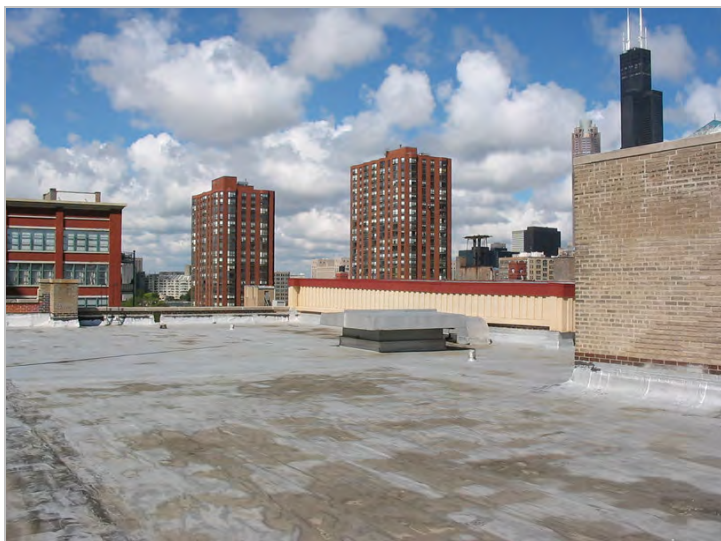
The flat roof is surfaced with a built-up bituminous material and is surrounded by a brick parapet with stone coping. Two penthouses are located on the roof. The north penthouse contains the rear stairs and freight elevator operating equipment. The east penthouse contains equipment for the passenger elevators. Both penthouses are of brick with stone coping. The texture of the brick suggests possible sandblasting in the past. An original metal chimney is located atop the north penthouse. Original brick chimneys with stone coping are located at the south end of the east and west walls.

View of roof surface, looking northwest

repaired. Repairs should be made while retaining ornamented limestone. *Note: many limestone units have been left on the roof. These should be evaluated and units that may be reusable stored.*

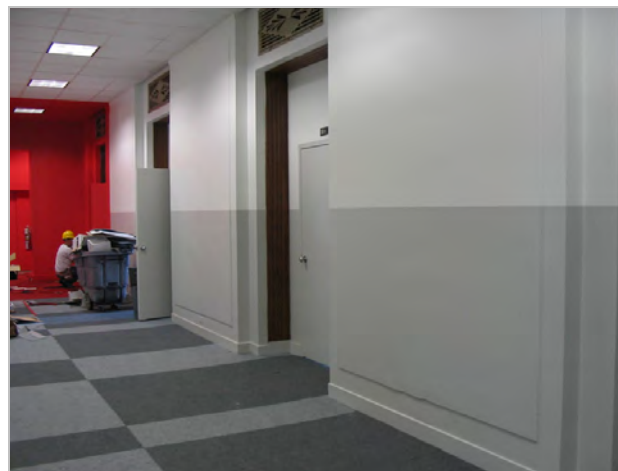
Third Floor Foyer, south wall with elevator lobby in background

The walls are of flat plaster with raised plaster panels between openings and set backs at the openings. Wood trim is located at the base of the wall and plaster wall trim is located just below a dropped ceiling. The original plaster ceiling is presumably under the suspended acoustical tile. Except for the patterned terrazzo floor at the elevators, the floor was originally carpeted. The entire floor, including the terrazzo, has recently been recarpeted.

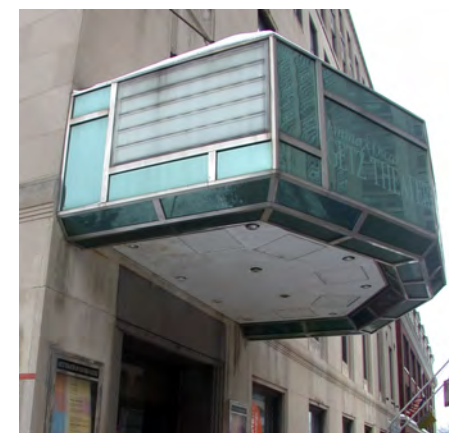
South elevation – downlights within canopy.

- If replicating the originals proves too daunting, downlighting may be integrated within the canopies so as not to call attention to itself. New fixtures should be sensitive to the architecture.
- At the very least, consideration should be given to replacing the existing downlights in the west canopy and the east entrance. The current fixtures have lamps partially exposed, creating unnecessary glare, which may detract from the appearance of the building.

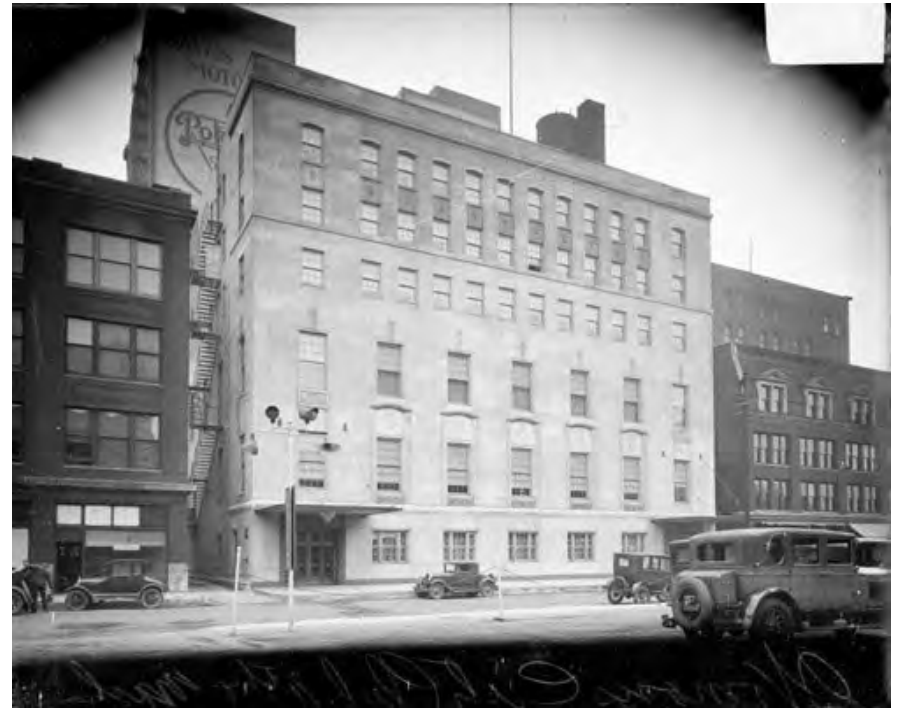
The original drawings by Holabird & Root show a single light in each canopy, as well as two lights located within the revolving door at the east entry. Only lighting wattages are noted. A photograph from 1930 shows a decorative fixture mounted to the underside of the west canopy, though it is too small to read any detail.

South elevation – historical photograph, c. 1930.
Note fixture mounted to underside of canopy.

- If planned restoration work involves the replacement of the original entry canopies, then the installation of lighting fixtures to replicate the originals should be considered.

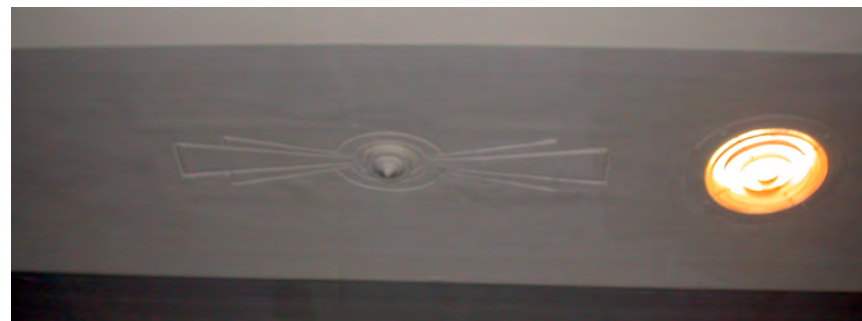
Within the Getz Theater, the lighting layout has changed considerably since the building was originally designed. The current lighting scheme consists of numerous incandescent downlights with white concentric ring louvers. The original layout used significantly fewer fixtures with higher wattages to illuminate the seating area. On the lower level, there were three fixtures beneath the balcony, as well as a series of steplights located along the central aisle. Tall sconces were mounted around the three sides of the audience; their locations can be seen in the drawings. Historical photographs show the style and scale of these sconces. The balcony utilized a similar layout to the floor level seating, with two large fixtures above the balcony seats and steplights down the aisles. One sconce appears to have been placed at the top landing of the stairs. In addition, four chandeliers were suspended above the audience in front of the balcony, and the four plaster ornaments marking their locations are still visible. These fixtures are visible in the historical photographs; they appear to be of the same family as the wall sconces.

Getz Theater – downlight beside former chandelier location.

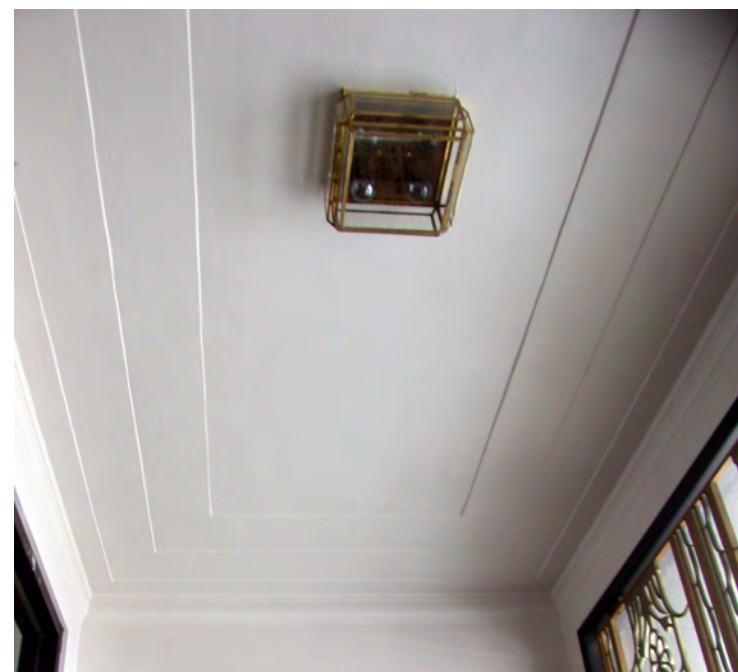
The west lobby has seen alterations to the lighting layout as well. The current layout includes a grid of ten recessed downlights with gold cones, two marquis-style sconces flanking the box office

West lobby vestibule – light fixture.

window, and a ceiling-mounted fixture in the vestibule which is in

- Similar treatments should be considered for the west lobby and foyer, replacing the original lighting fixtures and minimizing the appearance and impact of additional functional lighting systems.

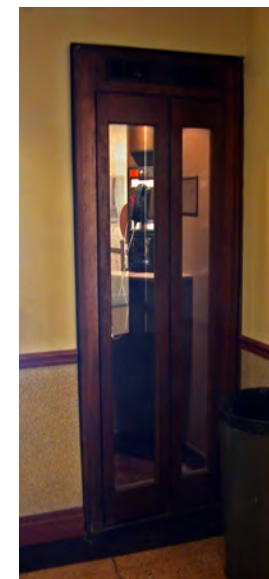
The original lighting design for the main lobby was essentially a mirror image of that in the west lobby. The current grid of downlights has replaced a large central fixture, whose original location is still marked by a junction box cover. Two sconces were mounted to the east wall; though their locations are no longer apparent, they are noted on the original drawings. A similar pair of sconces flanks the entry to the foyer from the elevator lobby. The telephone booths in the main lobby, with their integral door-activated downlights, do not appear to be original.

Phone booth with integral light.

but integrated into the architecture or decorative fixtures so as to remain as inconspicuous as possible. All unnecessary non-historic fixtures should be removed.

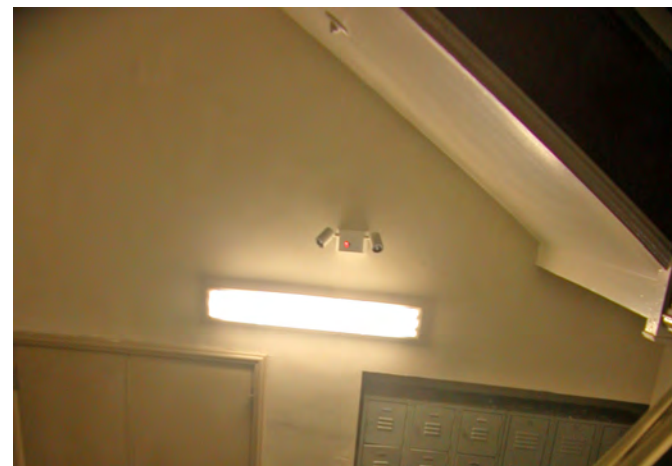
Main stairway fixtures – original pendant canopy visible.

- As with the spaces discussed previously, care should be taken to replace the original fixtures with new ones sympathetic to the original style and architecture. As necessary, additional functional lighting should be added,

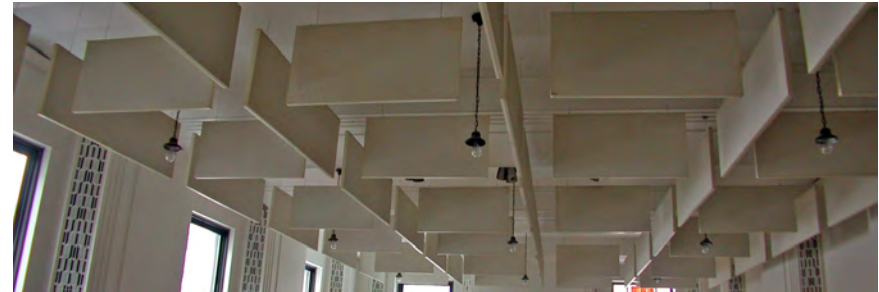
The theater classrooms on the second floor, formerly the main dining room, have had their lighting systems significantly altered from the original designs. The current lighting system consists of a grid of pendants with exposed incandescent A lamps. It appears as though the pendants had shades or diffusers at one point, but all have since been removed. Three double-headed spotlights are mounted to the side of a coffer at the west end of Room 211, but these no longer appear to be in use, and no evidence of them appears on the original plans. The locations of sconces, part of the original design, are still marked with junction box covers. Eight chandeliers appear to have provided most of the lighting in the original space; their locations are noted in the original plans.

Main dining room – bare A lamp pendants.

- The current light fixtures should be removed and replaced with fixtures sympathetic to the original architecture in the original locations. Decorative fixtures may be supplemented as needed with functional lighting, although any non-historic fixtures should remain as inconspicuous as possible.

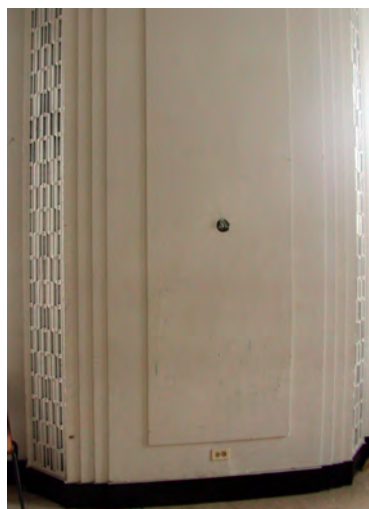
Main dining room – typical sconce location.

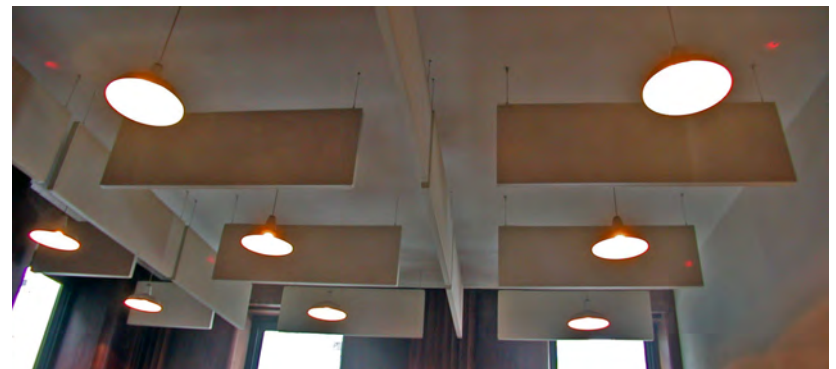
The third floor's acting studios, which were previously the lounge, have seen lighting changes similar to the main dining room. RLM-style pendants hang in a grid within the suspended acoustic panels. Junction box covers have been placed at former sconce locations on the fluted columns; locations and elevation sketches of these sconces are available in the drawings. To complement the sconces, the original drawings included four chandeliers. In historical photographs, these chandeliers appear to have been supplanted by table and floor lamps for general illumination.

Acting classrooms – RLM pendants.
