COLUMBIA COLLEGE CHICAGO  
CAMPUS PRESERVATION PLAN

Volume VI

624 SOUTH MICHIGAN AVENUE

Submitted by  
McGuire Igleski & Associates, Inc.

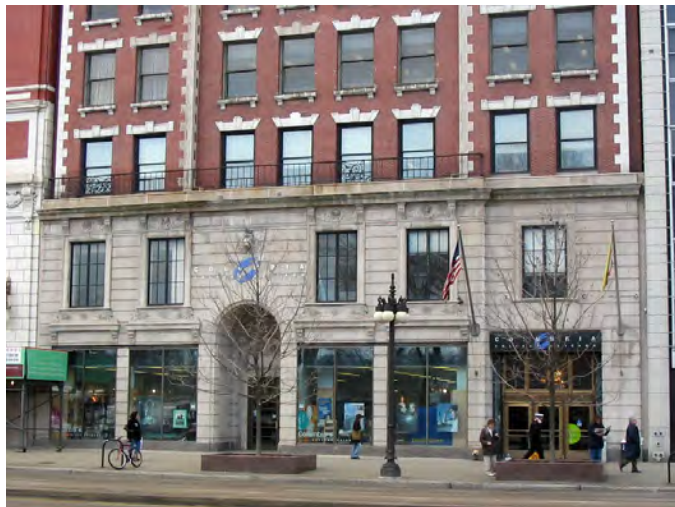
*Lower floors showing center and north entrances and bronze windows at second floor*

and the thirteenth story. The windows are detailed with terra cotta flat arches and sills supported by decorative brackets. Some original terra cotta lintels and quoins have been replaced in limestone. The terra cotta wall surface and ornament is in fair condition with some cracks.

The windows on the second story are paired bronze casements with six divided lights in each sash. The storefronts are replacements in aluminum. Because of the removal of the cornice, terra cotta ornament replaced in simplified limestone, and the replacement of the windows this façade has medium integrity.

- Continue regular façade inspections and maintenance.
- Repair terra cotta wall cladding, window lintels and sills. If too deteriorated to repair, replacement in kind is recommended for replacements. Routine maintenance of the brick includes appropriate tuckpointing as needed.

- Upper floor windows: when the replacement of the non-original windows is considered, the new units should replicate the appearance of the original. This work should be done based on available historic documentation and should incorporate restoration of both materials and design.

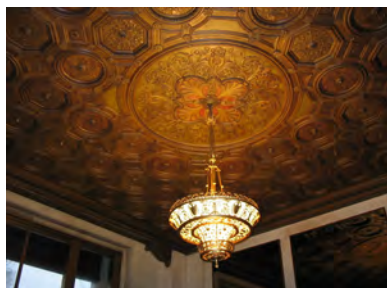
The entrance vestibule is rectangular in plan with marble floors now covered with carpet, and marble walls and baseboards. The ceiling is flat with an ornate, low-relief plaster ornament of geometric patterns and floral medallions painted in a polychromatic scheme. This ceiling treatment continues into the elevator lobby.

*Detail of vestibule ceiling*

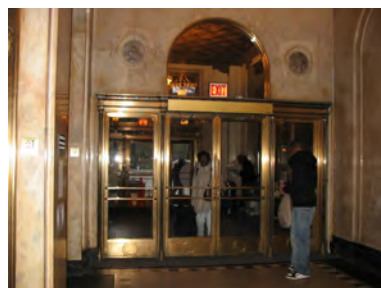
*Doors between lobby and vestibule*

The elevator lobby is rectangular in plan and is accessed from the vestibule through two pairs of 1920s bronze doors. The elevator bank and main stairway are located on the north wall. A newer security desk

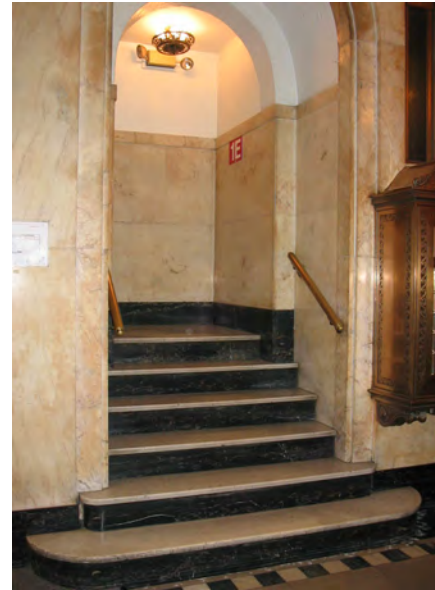
The main stairway at the lobby, also set within an arched marble opening, has marble steps, risers and walls. The round handrails on each side are bronze.

*Main stairway at the lobby*

- The jelly jar-style sconces in the stairway should be removed and replaced with fixtures more sensitive to the architectural character of the building.
- If permissible by code, the battery-powered emergency units and exposed conduit should be removed. New emergency lighting should be provided through emergency circuits in existing light fixtures.

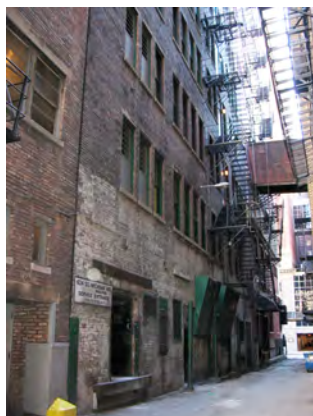
The west exterior elevation, faces an alley, and reflects its use as a service entrance. The wall is common brick with concrete at the base. Masonry at the upper floors is face brick set in a tromp l'oeil arrangement of brick “bays”. On the ground floor, there is a steel service door toward the north end of the building as well as a bay for loading and receiving. The windows on this elevation have limestone sills, terra cotta heads and the sash have been replaced with metal double hung units. Each floor has one steel door to access the fire escape.

*View of west elevation, facing alley*

- Continue regular façade inspections and maintenance.
- Maintain brick walls including tuckpointing and replacement of brick, particularly glazed brick, as necessary.
- Repair terra cotta window heads as necessary.

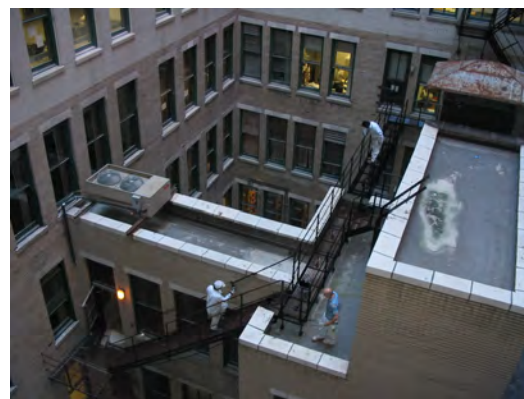
The south elevation is a common brick party wall with a larger lightcourt at the center of the elevation. The lightcourt walls are glazed brick with limestone coping. At the fifth and sixth stories, the lightcourt is divided into two halves, separated by an interior corridor and elevator bank. At the seventh floor and above, the lightcourt becomes a unified space.

*View of lightcourts, divided by elevator shaft*

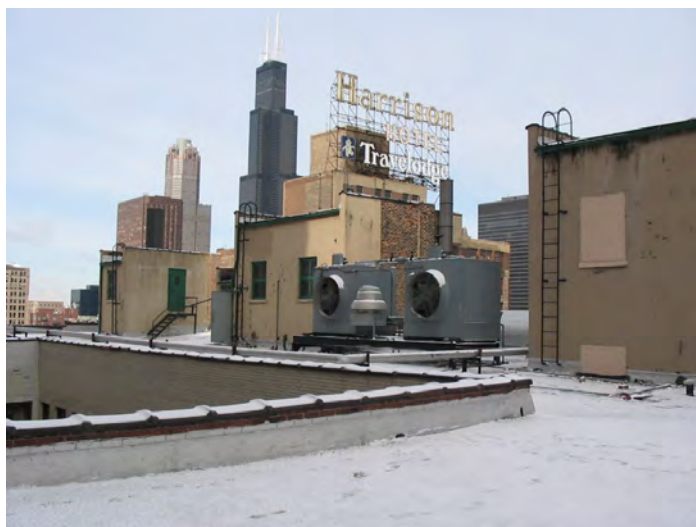
The roof is flat and surfaced with built-up bituminous roofing. The downspout system is internal. There is a round brick chimney and three penthouses that house mechanical equipment. The walls are common brick, some parged and have a clay tile coping. The east facing parapet walls have been rebuilt with brick and are capped with a limestone coping.

*View of roof looking northwest.*

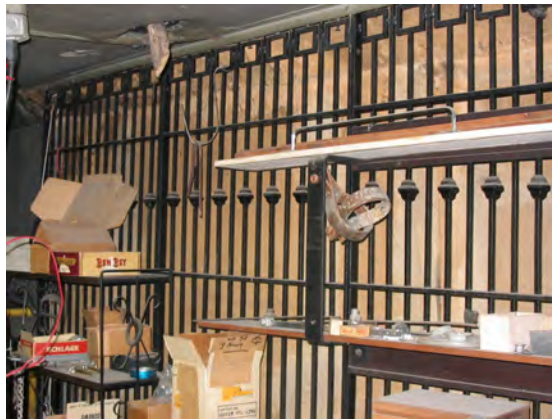
The basement is included in this zone. The basement space is non-public and serves the mechanical and storage needs of the building. In the southwest corner there is an original metal screen which enclosed the direct current electrical vault. At one time, a small portion of the basement, at the east, had public uses. Consequently, there are remnants of historic finishes in this area including ornamental plaster and terrazzo floors.

*Extant metal screen at former DC vault*

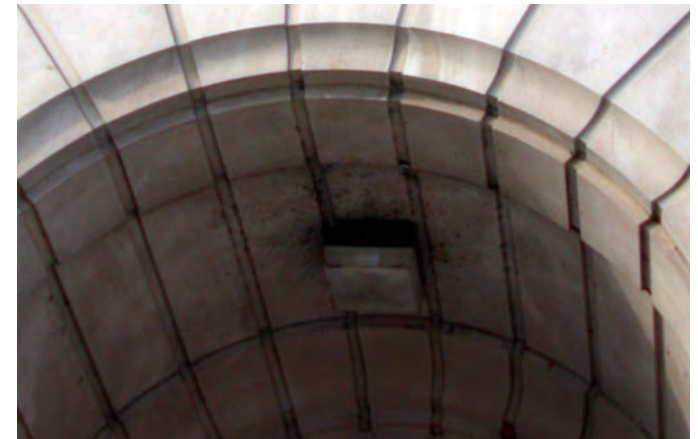
East elevation – HID downlight in arched entryway.

- The black floodlights and exposed electrical conduit are not integrated within the architecture. These fixtures should be removed and a new lighting scheme, integrated with the building or nearby street lighting poles, should be designed.
- The existing HID downlight should be removed and replaced with a new fixture that replicates the original lantern. All efforts should be made to recreate the original fixture with regard to detailing, materials and finishes.

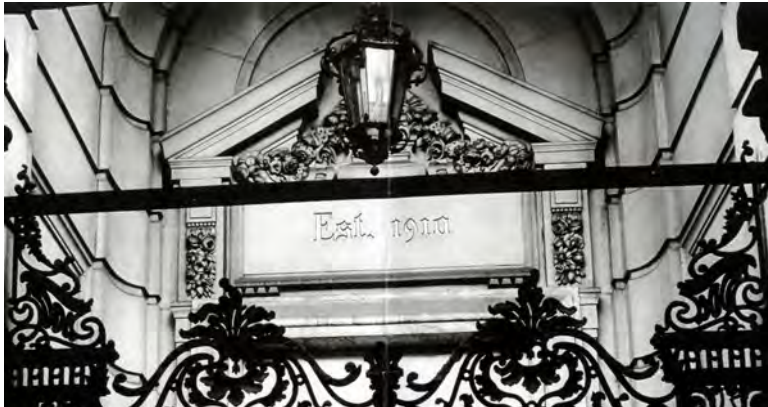
East elevation – historic lantern in arched entryway.

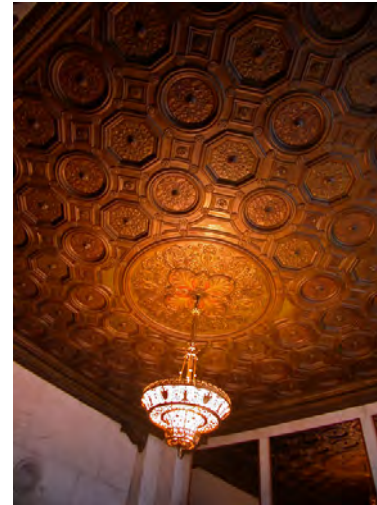
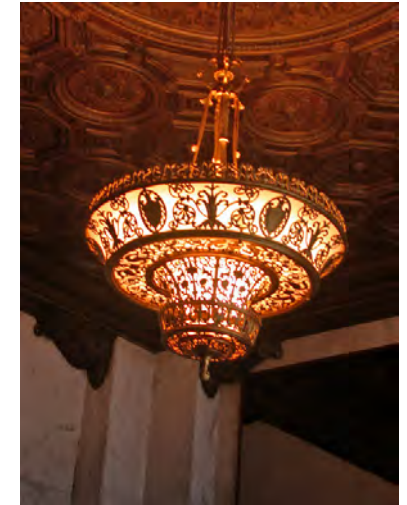
An incandescent chandelier without a diffuser can be seen at the bottom of the main stairway. The remainder of the main stairway is illuminated by jelly jar-style sconces at the landings. Battery-operated units provide emergency lighting. *[See pictures.]*

In addition, there are what appear to be small sconces above each set of elevator doors, perhaps to act as a marker light for arriving

Entrance vestibule – chandelier.

elevator cabs. Whatever they might have been, they are no longer present. *[See picture.]*

- The chandeliers and sconces, which appear to be original, should be refurbished and returned to their original state, including finishes and lamping.
- The historic fixtures may need to be supplemented with additional functional lighting. If so, the appearance of these fixtures should be minimized.

- The jelly jar-style sconces in the stairway should be removed and replaced with fixtures more sensitive to the architectural character of the building.
- If permissible by code, the battery-powered emergency units and exposed conduit should be removed. New emergency lighting should be provided through emergency circuits in existing light fixtures.

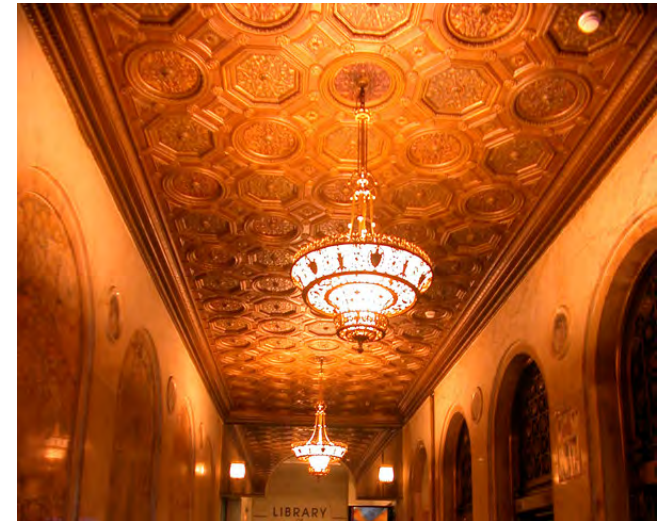
Elevator lobby.

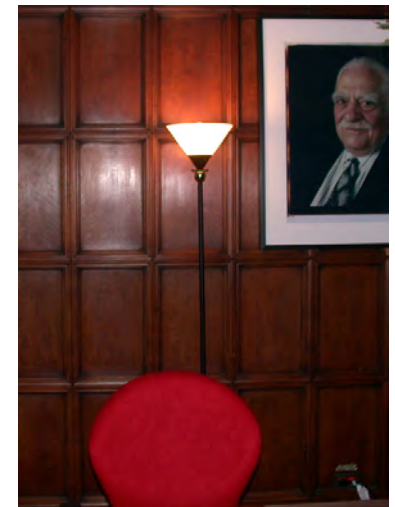
Conference room – torchiere.

- The existing track and torchieres should be removed and replaced with a lighting system that is more sensitive to the architectural character of the space. Since the function of the room is significantly different than that for which it was originally designed, every effort should be made to minimize the impact and visibility of any new, non-historic lighting.

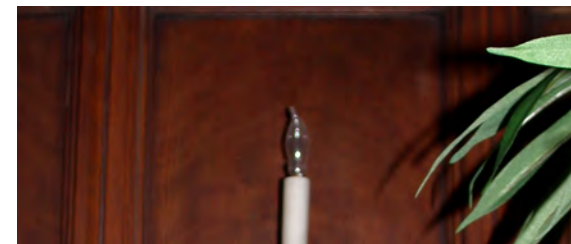
Conference room – possible original sconce.
