COLUMBIA COLLEGE CHICAGO  
CAMPUS PRESERVATION PLAN

Volume VII

1014 SOUTH MICHIGAN AVENUE

Submitted by  
McGuire Igleski & Associates, Inc.

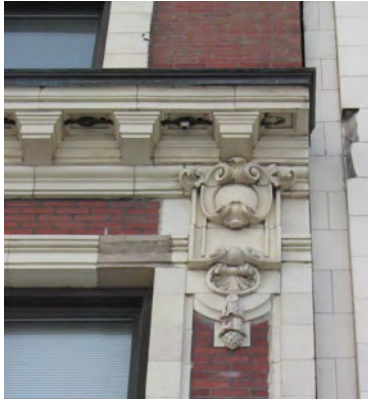
The terra cotta elements are in good to fair condition, with some cracks, spalls, and displaced units. There are non-matching replacement units and patched units. Damaged terra cotta at window lintels is an indication of steel corrosion; other cracking may be a result of differential settlement. The terra cotta deterioration appears to have been routinely maintained for the short term.

*Detail of Terra Cotta ornament at third floor*

- Conduct a comprehensive façade inspection to identify problem areas and design a program for terra cotta and brick repair. Conduct comprehensive terra cotta and brick façade restoration including repair and replacement of deteriorated terra cotta and anchors; tuckpointing with an appropriate mortar; and new sealants at wash joints and windows. Maintain granite wall base by performing routine inspections to locate and correct causes of deterioration.

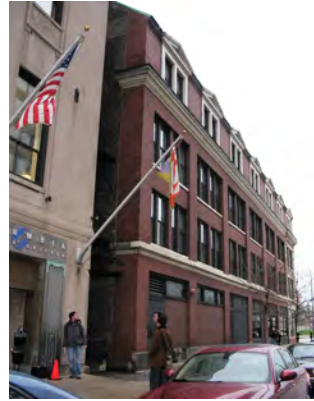
*Brick and terra cotta returns at south elevation*

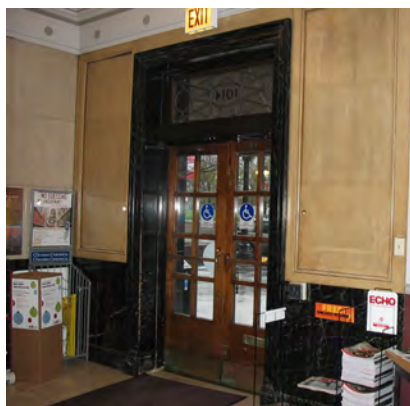
*Detail of main entrance*

- The fluorescent striplights and their associated exposed conduit behind the awning are large and conspicuous. Fixtures should be replaced with smaller, better concealed fixtures, which can illuminate the entryway and not attract attention to them.

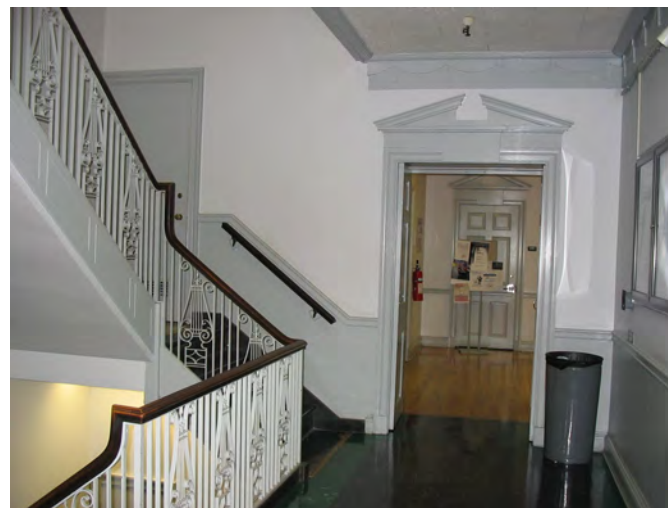
These spaces retain a high degree of integrity.

*Typical floor landing*

- The surface-mounted fluorescent fixtures in the stairwell should be replaced with fixtures in the original locations, and all

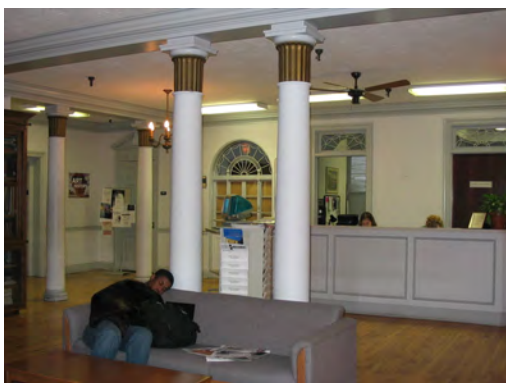
*View of Third Floor Lobby*

- Replace the lights in the third floor lobby. Replacement fixtures should be installed in the original locations, as shown in the drawings, and every effort should be made to be sensitive to the original design.
- Replace the fluorescent fixtures in the chairman's office with fixtures that replicate the originals installed in 1946. These should match replacement fixtures in the lobby.
- Refurbish and reinstall the original shelf lights in the chairman's office. If they cannot be refurbished, replicas should be made to replace them.
- If necessary, additional functional lighting may need to be added to supplement new light fixtures. The appearance of any additional, non-historic lighting should be minimized.

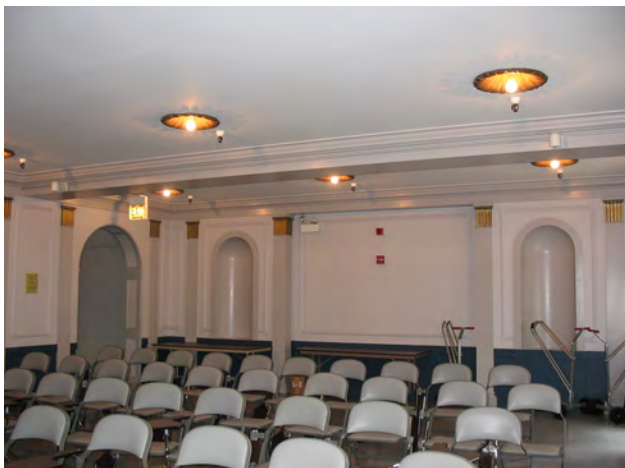
The Recital Hall (Classroom 207) is an ornamented space with finishes similar to those found in the Third Floor Lobby. A simple vestibule separates the corridor from the recital hall and provides access to an adjoining coat room. The arched ceiling has been covered with suspended ceiling tiles.

*View of Recital Hall from stage*

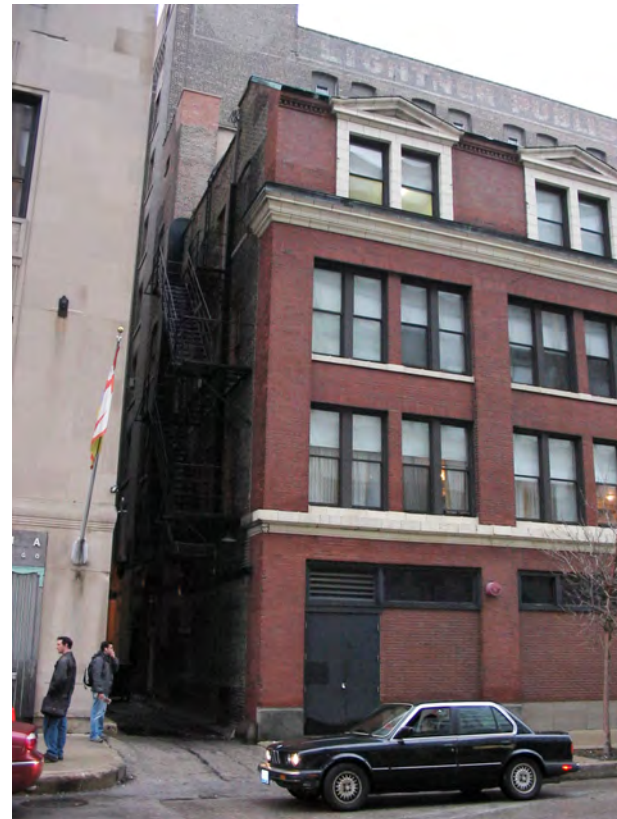
*View into alley west of building*

- Conduct a comprehensive façade inspection to identify problem areas and design a program for repair. Repair limestone and tuckpoint brick as necessary.

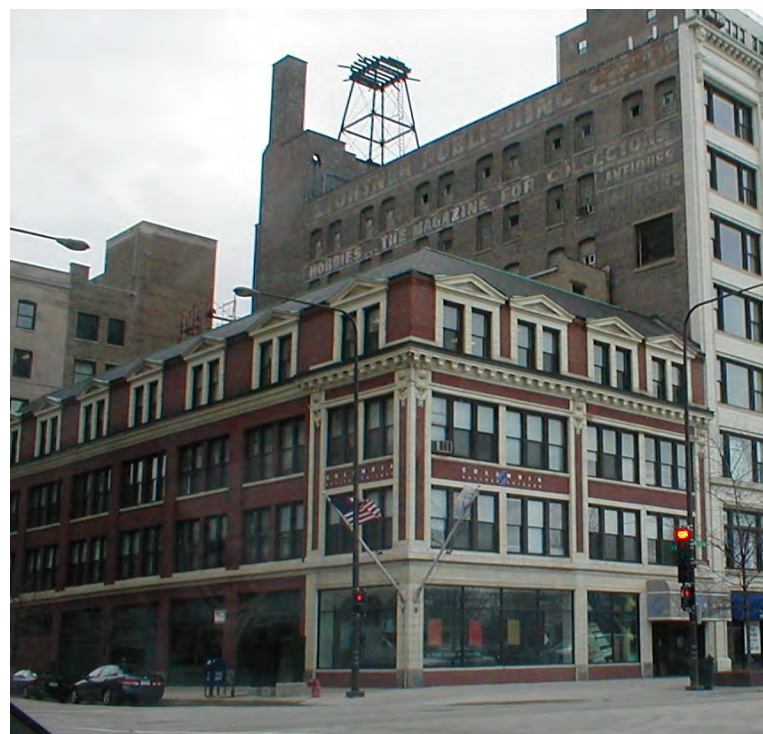
Mechanical equipment on the roof includes but is not limited to: elevator equipment rooms, packaged HVAC units, exhaust fans, chimneys, and air-cooled air conditioning condensers.

*View showing the high visibility of the roof*

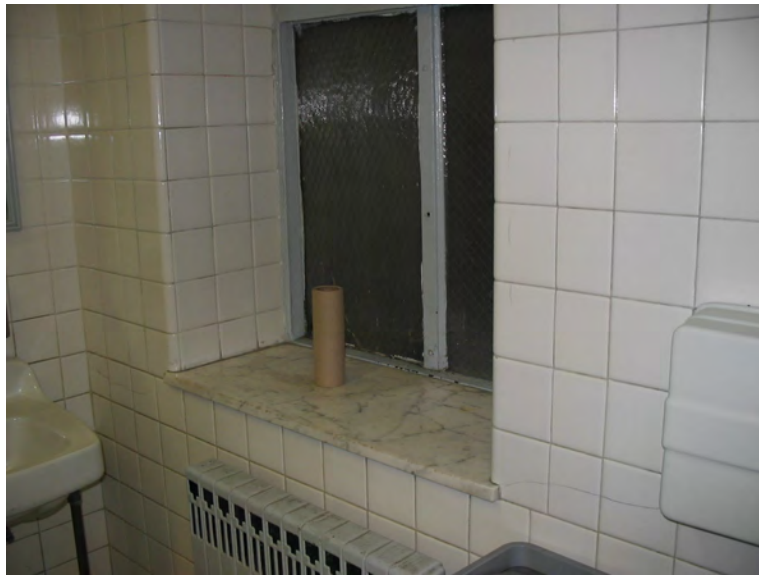
1014\_012605\_78.jpg

Zone Number & Description	Element Name	Description	Rating	Condition	Quantity	Photograph
4A - Non-historic / Significantly Altered Spaces	Interior Door Casing/Trim	Wood	2	Good	70 lf	  1014_012605_72.jpg
				Fair	lf	
				Poor	lf	
				Unknown	lf	
				Total:	70 lf	
4A - Non-historic / Significantly Altered Spaces	Interior Door Framed Opening	Wood	2	Good	70 sf	  1014_012605_73.jpg
				Fair	sf	
				Poor	sf	
				Unknown	sf	
				Total:	70 sf	
4A - Non-historic / Significantly Altered Spaces	Wall Surface	Plaster	2	Good	23,000 sf	  1014_012605_33_a.jpg
				Fair	sf	
				Poor	sf	
				Unknown	sf	
				Total:	23,000 sf	
4A - Non-historic / Significantly Altered Spaces	Wall Surface	Vitrolite	2	Good	500 sf	  1014_012605_78.jpg
				Fair	sf	
				Poor	sf	
				Unknown	sf	
				Total:	500 sf

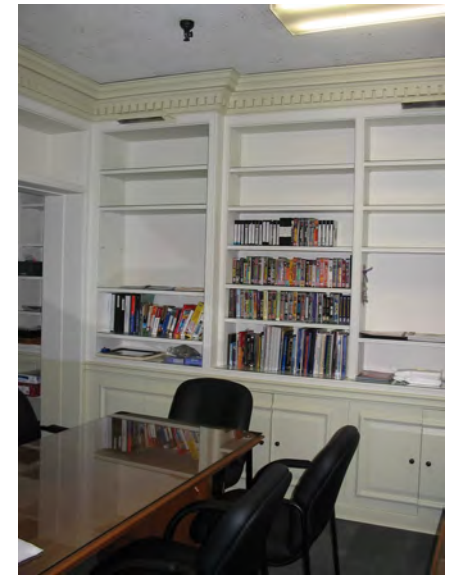
1014\_012605\_80.jpg

Zone Number & Description	Element Name	Description	Rating	Condition	Quantity	Photograph
4A - Non-historic / Significantly Altered Spaces	Floor Surface	Wood	2	Good	210 sf	  1014_012605_80.jpg
				Fair	85 sf	
				Poor	sf	
				Unknown	sf	
				Total:	295 sf	
4A - Non-historic / Significantly Altered Spaces	HVAC Equipment	Radiator	2	Good	50 each	  1014_1124_0008_a.jpg
				Fair	each	
				Poor	each	
				Unknown	each	
				Total:	50 each	
4A - Non-historic / Significantly Altered Spaces	Interior Door	Wood and Glass	2	Good	2 each	  1014_012605_72.jpg
				Fair	each	
				Poor	each	
				Unknown	each	
				Total:	2 each	
4A - Non-historic / Significantly Altered Spaces	Interior Door	Wood Panel	2	Good	2 each	  1014_012605_77.jpg
				Fair	each	
				Poor	each	
				Unknown	each	
				Total:	2 each

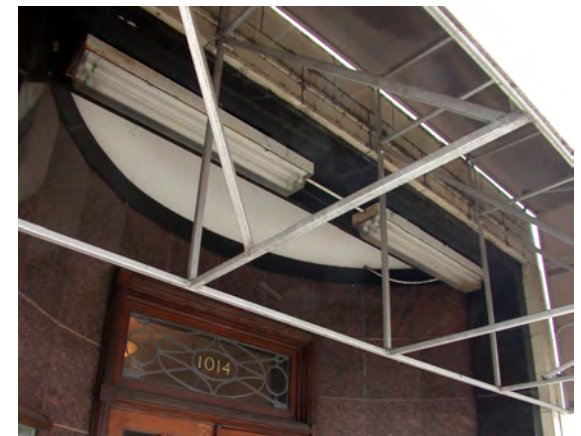
East elevation – striplights beneath awning at main entry.

- The floodlights, though small, are finished in black and are not integrated within the architecture. If desired, new lighting should be designed that better integrates with the building or nearby street lighting poles.
- The fluorescent striplights and their associated exposed conduit behind the awning are large and conspicuous. Fixtures should be replaced with smaller, better concealed fixtures, which can illuminate the entryway and not attract attention to themselves.

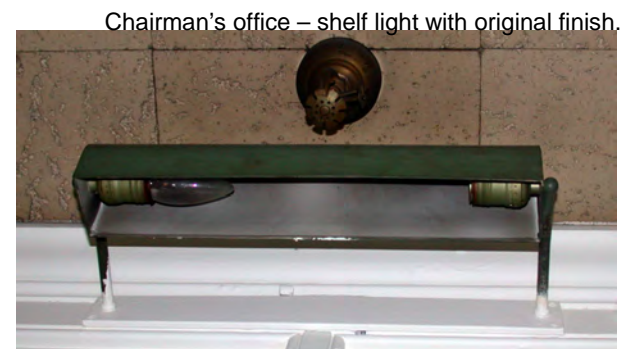
Chairman's office – painted shelf light.

- The fluorescent fixtures in the chairman's office should be replaced with fixtures that replicate the originals installed in 1946. These should match replacement fixtures in the lobby.
- The original shelf lights in the chairman's office should be refurbished and reinstalled in their existing locations. If they cannot be refurbished, replicas should be made to replace them.

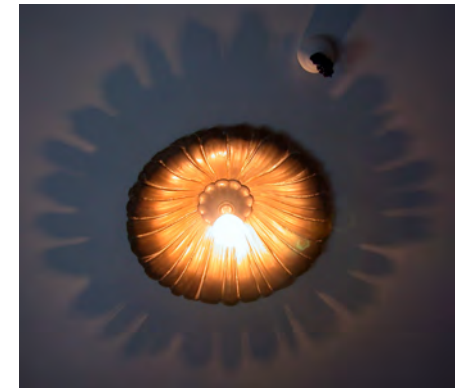
Recital hall – typical plaster “flower” fixture.

- As the current lighting appears to be original, effort should be taken to preserve it. Concealed stage lighting fixtures and socket strips may be replaced as necessary, but their replacements should not be more visible than the originals.
- The current A lamps in the “flower” fixtures appear to be too small for the scale of the plaster ornamentation. These should be relamped with larger G (globe) lamps, which were likely the type of lamps used originally.
- All original light fixtures should be professionally cleaned and refurbished. In addition, they should be re-wired to comply with current the electrical and building codes.

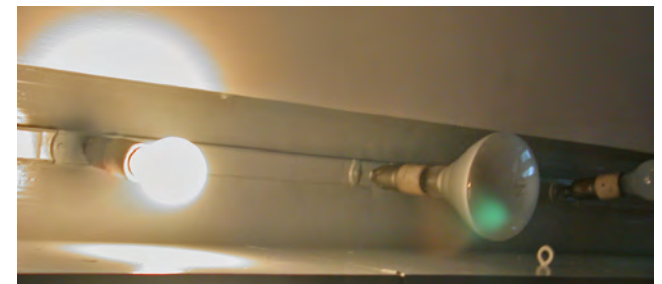
Recital hall – typical socket strip.
