**COLUMBIA COLLEGE CHICAGO
CAMPUS PRESERVATION PLAN**

Volume X

623 SOUTH WABASH AVENUE

June 2005

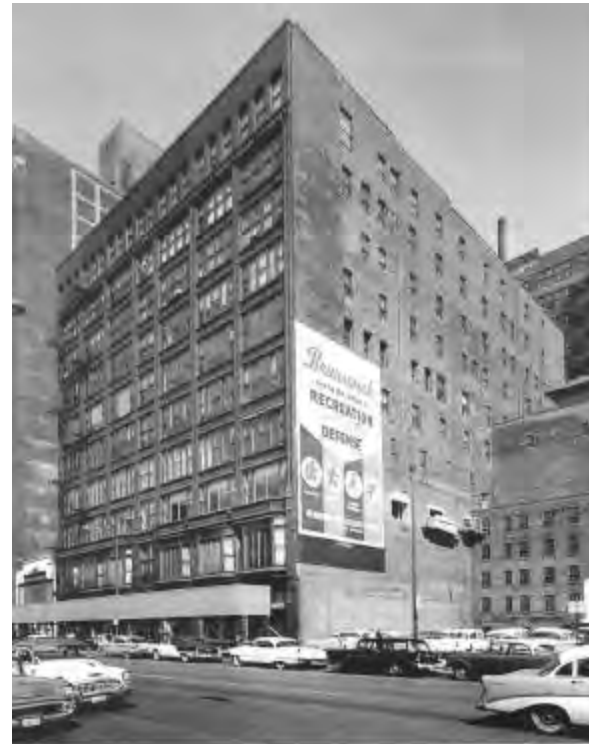
Overall, the building is in good condition and has a low degree of integrity. Restoration of the building's façade would improve its appearance and integrity.

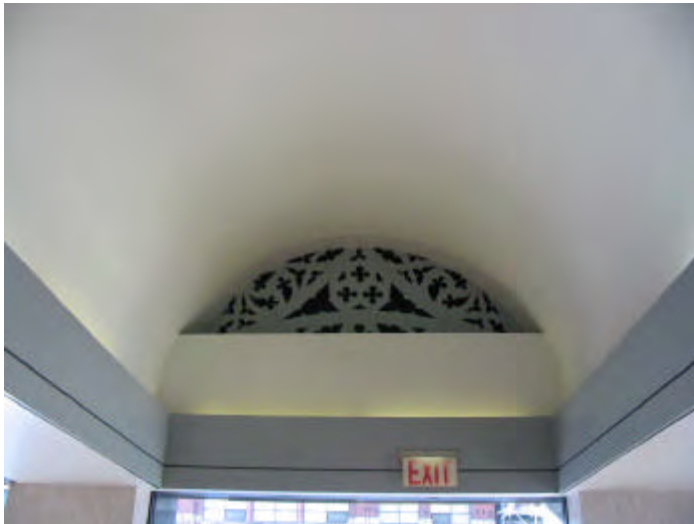
flanked with narrower operable sash. The narrow center bay has two windows with operable lower sash. The second floor projecting bays originally had Chicago Style windows with transoms. These windows have been replaced with metal and the original mullions have been clad. The ground floor has non-original, aluminum framed storefronts. The current storefront configuration is divided into two glass units to each bay. At the north end of the façade is the original fire escape. The main entrance is centrally located, consisting of a group of three contemporary aluminum and glass doors. Some original ornament at entrance transom is still visible from the interior.

Transom ornament viewed from the interior

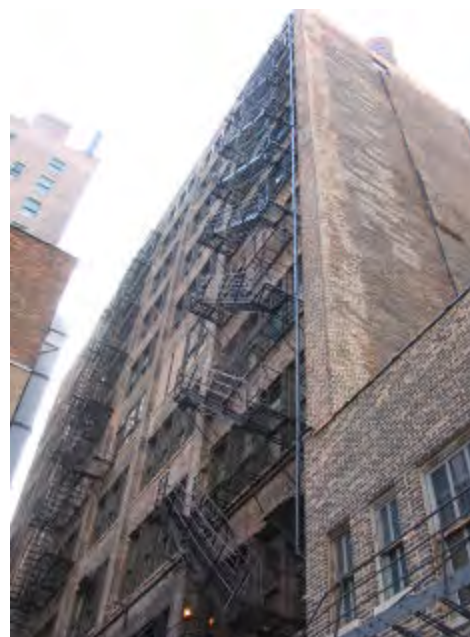
There are two fire escape stairs on the east elevation: one stair at the north end and a second at the center.

East wall detail showing fire escapes

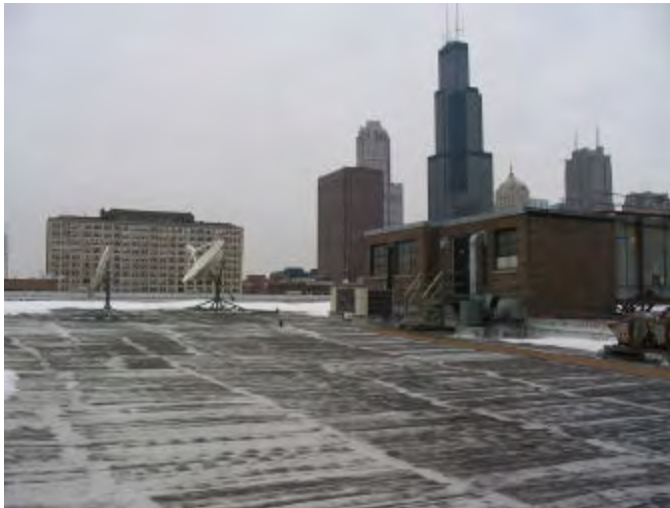
The roof is flat and the surface is built-up bituminous material. The downspout system is internal. The brick parapet walls have clay tile coping at the sides and rear, and sheet metal coping at the front (west).

There are penthouses which houses mechanical equipment, there is a large round brick chimney, and satellite dishes.

View of roof

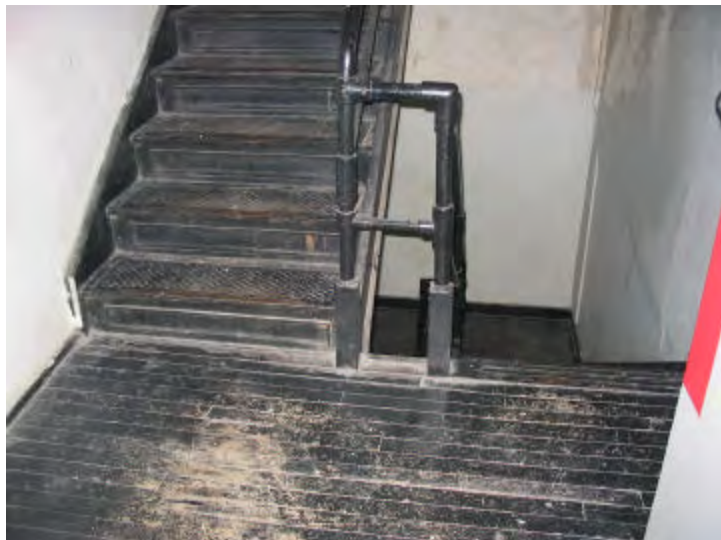
The landing floors are original hardwood and have been painted. The walls and ceilings are smooth, painted plaster.

Detail of east stairway

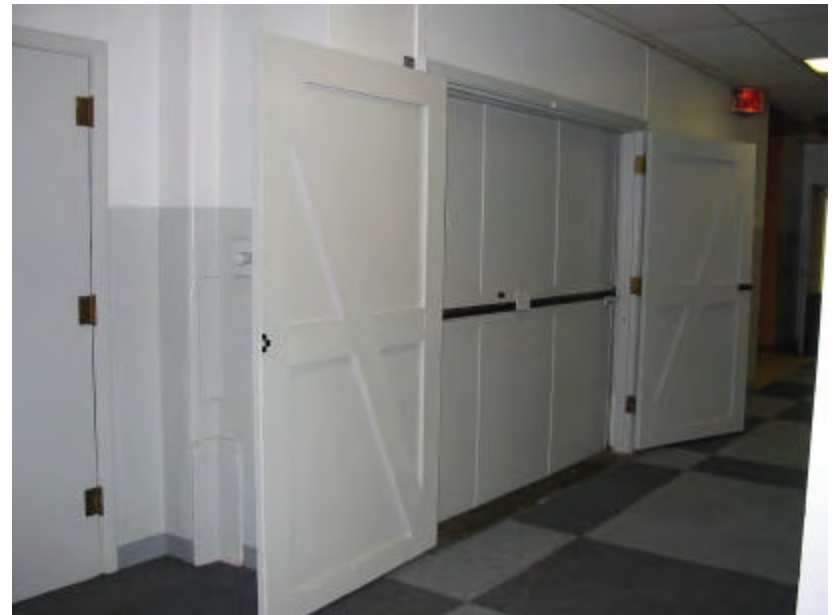
The original, large freight elevator is located directly adjacent to the east stairwell.

Freight elevator

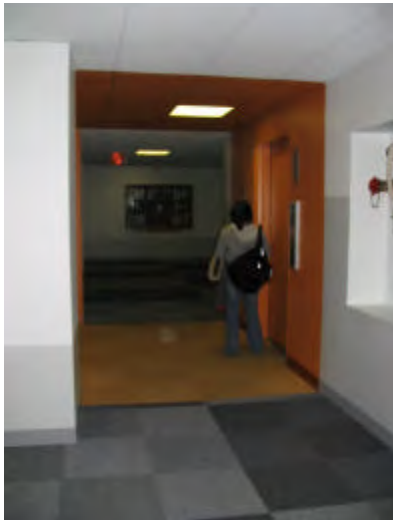
The result is that most original interior spaces, circulation patterns and finishes are no longer extant. However, most floors still have the original maple hardwood flooring under contemporary carpet and tile. Other historic finishes have been covered over or removed.

View of rehabilitated interior circulation spaces

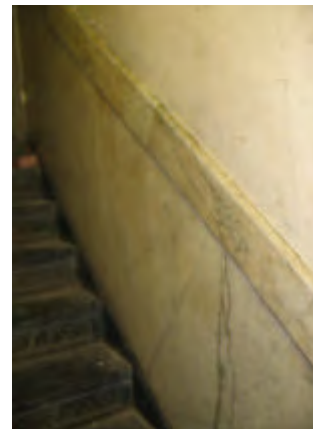
Marble treads and wainscoting

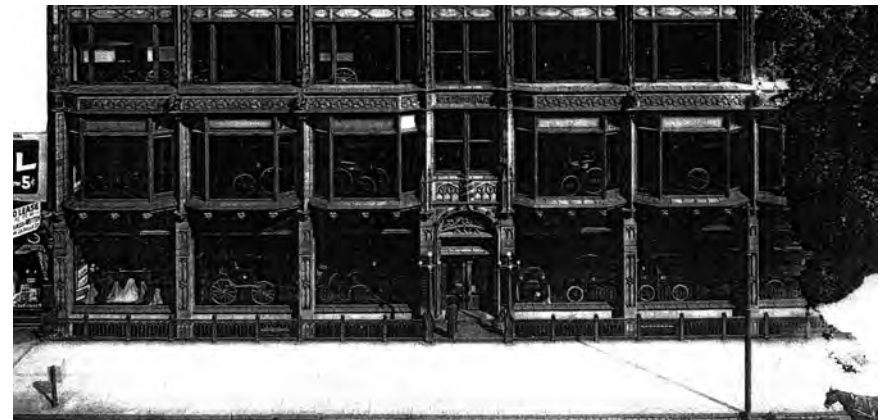
Historical photographs show only two original light fixtures, poles with globe clusters flanking the main entrance on Wabash. *[See picture.]* Although details are difficult to discern, the poles appear to be topped with a central globe, orbited by four smaller globes. It is entirely likely that these represent the extent of the original exterior lighting scheme.

West elevation - historical photograph with original light poles visible.

- The HID fixtures are a significant intrusion on the character of the building. Given the locations of existing lighting poles along the sidewalk, these fixtures are most likely unnecessary for pedestrian illumination and are a significant source of glare. These HID fixtures should be removed and, if desired, replaced with wall mounted fixtures replicating the original globe fixtures.
- Spot lighting could be added to accent structural features of the façade. These could possibly be concealed by the restored globe fixtures.
